Access Compliance Report

## Public Rights-of-Way
(Curb Ramps)

Intersection ID: 19665	**Main Street:** BROWN-GRIER_RD	**Cross Street:** WILD_DOGWOOD_CT	**Location:** NE
ADA ID: 47F091676881	**Ramp Type:** PerpDiag	**Initial Pass/Fail:** Fail **Overall Compliance:** No	**Severity Score:** 12.5

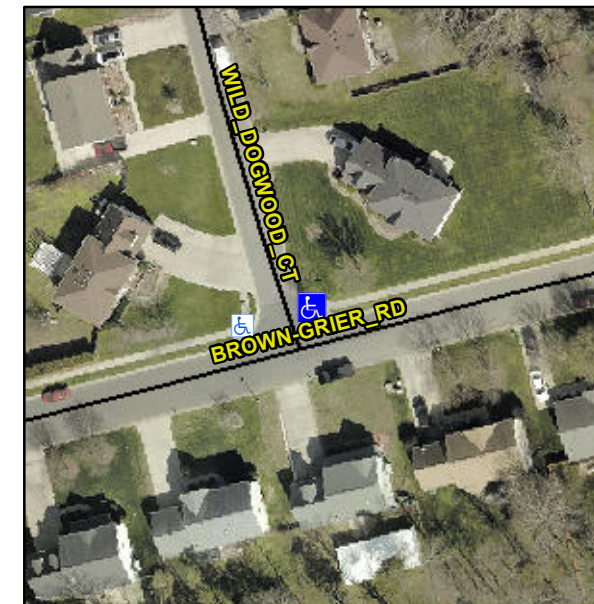
Compliance	Description	Data	Compliance	Description	Data
N/A	Ramp Length (in)	96.0	Yes	Ramp Slope (%)	5.6
Yes	Ramp Width (in)	50.0	No	Ramp XSlope (%)	6.9
N/A	Flare Type LT	N/A	N/A	Flare Type RT	N/A
N/A	Flare Slope LT (%)	N/A	N/A	Flare Slope RT (%)	N/A
N/A	Flare Traversable LT?	N/A	N/A	Flare Traversable RT?	N/A
N/A	Landing Length (in)	N/A	N/A	DWS Provided?	N/A
N/A	Landing Width (in)	N/A	N/A	DWS Contrast?	N/A
N/A	Landing Slope (%)	N/A	N/A	DWS Length (in)	N/A
N/A	Landing X Slope (%)	N/A	N/A	DWS Full Width?	N/A
N/A	Landing Curb? (Y/N)	N/A	N/A	DWS Offset (in)	N/A
N/A	Shared Landing?	N/A			
N/A	Gutter Ponding?	N/A	N/A	Gutter Slope (%)	N/A
N/A	Gutter Lip Ht (in)	N/A	N/A	Gutter X Slope (%)	N/A
N/A	Painted X Walk1?	No	N/A	Painted X Walk2?	No
	X Walk 1 Direction	To W		X Walk 2 Direction	To S
N/A	X Walk 1 Width (in)	N/A	N/A	X Walk 2 Width (in)	N/A
	X Walk 1 Slope (%)	0.1		X Walk 2 Slope (%)	1.4
	X Walk 1 X Slope (%)	3.5		X Walk 2 X Slope (%)	0.0

Remove & Replace Curb Ramp With Two New Directional Ramps or Equivalent.
