Access Compliance Report
Public Rights-of-Way
(Curb Ramps)

Intersection ID: 3847 **Main Street:** HIGHSTREAM_CT **Cross Street:** POPLAR_GROVE_DR **Location:** NE

ADA ID: 49BEE6701DDC **Ramp Type:** Perp **Initial Pass/Fail:** Fail **Overall Compliance:** No **Severity Score:** 25

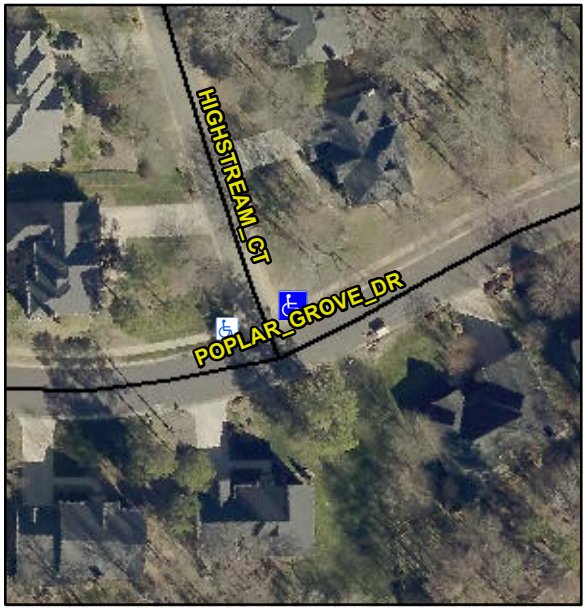
R304.2.2, R304.5.3

Compliance	Description	Data	Compliance	Description	Data
N/A	Ramp Length (in)	41.0	No	Ramp Slope (%)	8.4
Yes	Ramp Width (in)	48.0	No	Ramp XSlope (%)	6.8
N/A	Flare Type LT	N/A	N/A	Flare Type RT	N/A
N/A	Flare Slope LT (%)	N/A	N/A	Flare Slope RT (%)	N/A
N/A	Flare Traversable LT?	N/A	N/A	Flare Traversable RT?	N/A
N/A	Landing Length (in)	N/A	N/A	DWS Provided?	N/A
N/A	Landing Width (in)	N/A	N/A	DWS Contrast?	N/A
N/A	Landing Slope (%)	N/A	N/A	DWS Length (in)	N/A
N/A	Landing X Slope (%)	N/A	N/A	DWS Full Width?	N/A
N/A	Landing Curb? (Y/N)	N/A	N/A	DWS Offset (in)	N/A
N/A	Shared Landing?	N/A			
N/A	Gutter Ponding?	N/A	N/A	Gutter Slope (%)	N/A
N/A	Gutter Lip Ht (in)	N/A	N/A	Gutter X Slope (%)	N/A
N/A	Painted X Walk1?	No	N/A	Painted X Walk2?	N/A
	X Walk 1 Direction	To W		X Walk 2 Direction	N/A
N/A	X Walk 1 Width (in)	N/A	N/A	X Walk 2 Width (in)	N/A
	X Walk 1 Slope (%)	4.7		X Walk 2 Slope (%)	N/A
	X Walk 1 X Slope (%)	5.0		X Walk 2 X Slope (%)	N/A

Remove & Replace Entire Ramp.
