Access Compliance Report
Public Rights-of-Way
(Curb Ramps)

Intersection ID: 43512	Main Street: BLUEBERRY_HOLLOW_PL	Cross Street: VICTORIA_BROOK_LN	Location: N
ADA ID: 49FF4DA686AB	Ramp Type: Perp	Initial Pass/Fail: Fail	Overall Compliance: No	Severity Score: 22.5

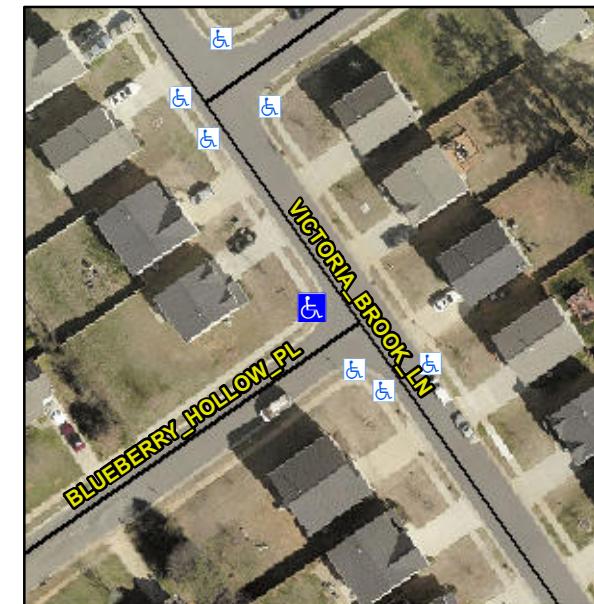
R304.5.1, R304.2.2, R304.5.3

Compliance	Description	Data	Compliance	Description	Data
N/A	Ramp Length (in)	46.0	No	Ramp Slope (%)	8.9
No	Ramp Width (in)	46.0	No	Ramp XSlope (%)	2.5
N/A	Flare Type LT	N/A	N/A	Flare Type RT	N/A
N/A	Flare Slope LT (%)	N/A	N/A	Flare Slope RT (%)	N/A
N/A	Flare Traversable LT?	N/A	N/A	Flare Traversable RT?	N/A
N/A	Landing Length (in)	N/A	N/A	DWS Provided?	N/A
N/A	Landing Width (in)	N/A	N/A	DWS Contrast?	N/A
N/A	Landing Slope (%)	N/A	N/A	DWS Length (in)	N/A
N/A	Landing X Slope (%)	N/A	N/A	DWS Full Width?	N/A
N/A	Landing Curb? (Y/N)	N/A	N/A	DWS Offset (in)	N/A
N/A	Shared Landing?	N/A			
N/A	Gutter Ponding?	N/A	N/A	Gutter Slope (%)	N/A
N/A	Gutter Lip Ht (in)	N/A	N/A	Gutter X Slope (%)	N/A
N/A	Painted X Walk1?	No	N/A	Painted X Walk2?	N/A
	X Walk 1 Direction	To S		X Walk 2 Direction	N/A
N/A	X Walk 1 Width (in)	N/A	N/A	X Walk 2 Width (in)	N/A
	X Walk 1 Slope (%)	5.0		X Walk 2 Slope (%)	N/A
	X Walk 1 X Slope (%)	5.0		X Walk 2 X Slope (%)	N/A

Remove & Replace Entire Ramp.
