Access Compliance Report
Public Rights-of-Way
(Curb Ramps)

Intersection ID: 29984	**Main Street: CORBETT_SQUARE_LN**	**Cross Street: OLD_CAROLINA_DR**	**Location:**	**NE**
ADA ID: 4B72E955917E	**Ramp Type: PerpDiag**	**Initial Pass/Fail: Fail**	**Overall Compliance: No**	**Severity Score: 46.25**

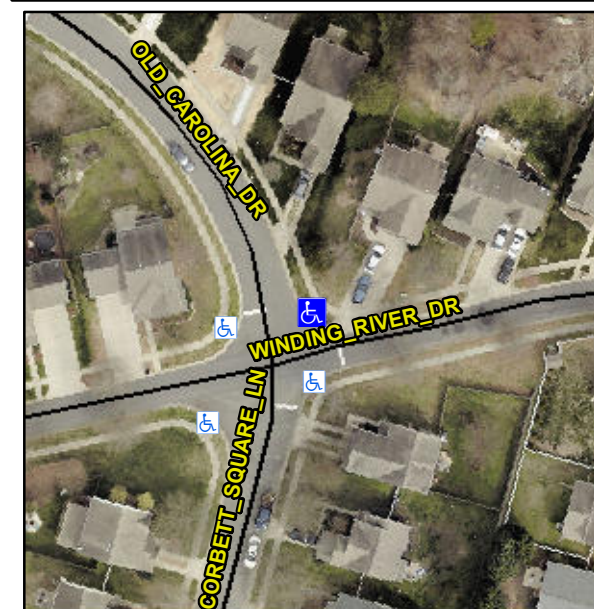
Not Found, R304.5.1, R304.2.2, R304.5.3

Compliance	Description	Data	Compliance	Description	Data
N/A	Ramp Length (in)	72.0	No	Ramp Slope (%)	8.4
No	Ramp Width (in)	46.0	No	Ramp XSlope (%)	12.2
N/A	Flare Type LT	N/A	N/A	Flare Type RT	N/A
N/A	Flare Slope LT (%)	N/A	N/A	Flare Slope RT (%)	N/A
N/A	Flare Traversable LT?	N/A	N/A	Flare Traversable RT?	N/A
N/A	Landing Length (in)	N/A	N/A	DWS Provided?	N/A
N/A	Landing Width (in)	N/A	N/A	DWS Contrast?	N/A
N/A	Landing Slope (%)	N/A	N/A	DWS Length (in)	N/A
N/A	Landing X Slope (%)	N/A	N/A	DWS Full Width?	N/A
N/A	Landing Curb? (Y/N)	N/A	N/A	DWS Offset (in)	N/A
N/A	Shared Landing?	N/A			
N/A	Gutter Ponding?	N/A	N/A	Gutter Slope (%)	N/A
N/A	Gutter Lip Ht (in)	N/A	N/A	Gutter X Slope (%)	N/A
N/A	Painted X Walk1?	No	N/A	Painted X Walk2?	No
	X Walk 1 Direction	To W		X Walk 2 Direction	To S
N/A	X Walk 1 Width (in)	N/A	N/A	X Walk 2 Width (in)	N/A
	X Walk 1 Slope (%)	5.8		X Walk 2 Slope (%)	1.6
	X Walk 1 X Slope (%)	4.2		X Walk 2 X Slope (%)	8.8

Remove & Replace Curb Ramp With Two New Directional Ramps or Equivalent.
