Access Compliance Report
Public Rights-of-Way
(Curb Ramps)

Intersection ID: 10041631	Main Street: WHITEHALL_PARK_DR	Cross Street: N/A	Location:	SW
ADA ID: 4C0555246644	Ramp Type: BlendTrans2	Initial Pass/Fail: Fail	Overall Compliance: No	Severity Score: 18.75

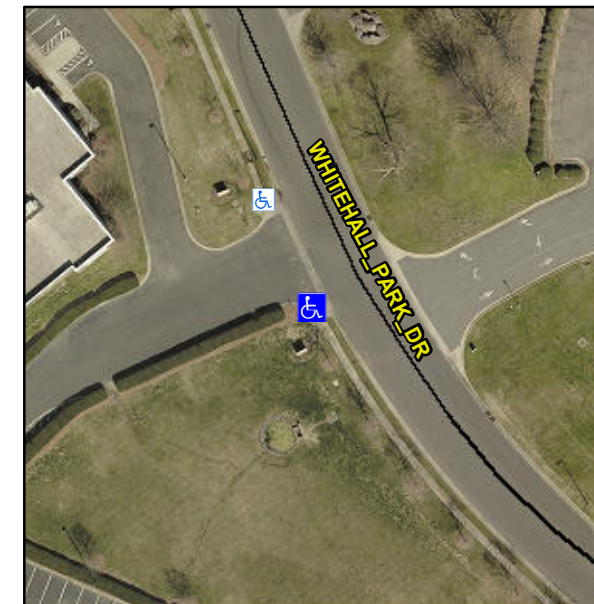
Not Found, R304.5.1, R304.5.3

Compliance	Description	Data	Compliance	Description	Data
N/A	Ramp Length (in)	97.0	Yes	BlendTrans Slope (%)	4.8
No	Ramp Width (in)	34.0	No	BlendTrans XSlope (%)	3.8
N/A	Flare Type LT	N/A	N/A	Flare Type RT	N/A
N/A	Flare Slope LT (%)	N/A	N/A	Flare Slope RT (%)	N/A
N/A	Flare Traversable LT?	N/A	N/A	Flare Traversable RT?	N/A
N/A	Landing Length (in)	N/A	N/A	DWS Provided?	N/A
N/A	Landing Width (in)	N/A	N/A	DWS Contrast?	N/A
N/A	Landing Slope (%)	N/A	N/A	DWS Length (in)	N/A
N/A	Landing X Slope (%)	N/A	N/A	DWS Full Width?	N/A
N/A	Landing Curb? (Y/N)	N/A	N/A	DWS Offset (in)	N/A
N/A	Shared Landing?	N/A			
N/A	Gutter Ponding?	N/A	N/A	Gutter Slope (%)	N/A
N/A	Gutter Lip Ht (in)	N/A	N/A	Gutter X Slope (%)	N/A
N/A	Painted X Walk1?	No	N/A	Painted X Walk2?	No
	X Walk 1 Direction	To E		X Walk 2 Direction	To N
	X Walk 1 Width (in)	N/A		X Walk 2 Width (in)	N/A
	X Walk 1 Slope (%)	0.4		X Walk 2 Slope (%)	2.6
	X Walk 1 X Slope (%)	1.4		X Walk 2 X Slope (%)	3.4

N/A	Ramp inside XWalk1?	N/A	N/A	Ramp inside XWalk2?	N/A
	Road Slope (%)	3.1		Clear Space?	N/A
	Road X Slope (%)	0.2	N/A	Clear Space to XWalk (in)	N/A
N/A	Any Obstructions?	N/A	N/A	Storm Grate/Utility Hazard?	N/A
	Obstruction Type			Storm Grate/Utility Type	
N/A					N/A
			Yes	Surface Condition? (G/P)	Good
			No	Curb Slope (%)	24.9

Remove & Replace Curb Ramp With Two New Directional Ramps or Equivalent.
