Access Compliance Report
Public Rights-of-Way
(Curb Ramps)

Intersection ID: 24962	**Main Street: KENLAUREN_TR**	**Cross Street: WILDBRACKEN_CT**	**Location: SW**
ADA ID: 4C3DF2B7AF5A	**Ramp Type: PerpDiag**	**Initial Pass/Fail: Fail**	**Overall Compliance: No** / **Severity Score: 13.75**

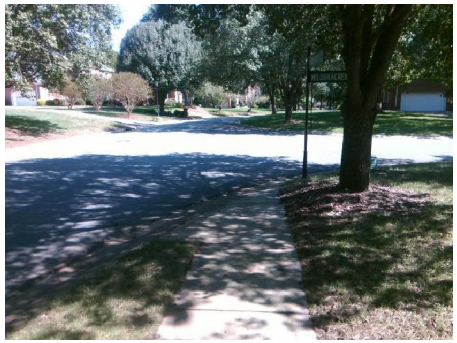
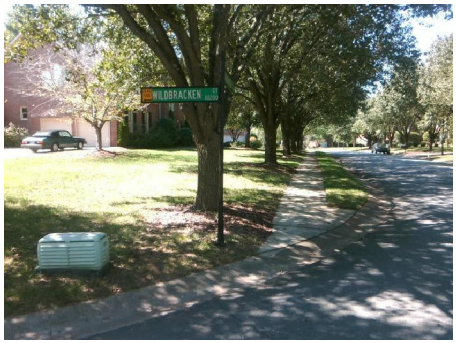
Not Found, R304.2.2, R304.5.3

Compliance	Description	Data	Compliance	Description	Data
N/A	Ramp Length (in)	56.0	No	Ramp Slope (%)	8.5
Yes	Ramp Width (in)	48.0	No	Ramp XSlope (%)	3.7
N/A	Flare Type LT	N/A	N/A	Flare Type RT	N/A
N/A	Flare Slope LT (%)	N/A	N/A	Flare Slope RT (%)	N/A
N/A	Flare Traversable LT?	N/A	N/A	Flare Traversable RT?	N/A
N/A	Landing Length (in)	N/A	N/A	DWS Provided?	N/A
N/A	Landing Width (in)	N/A	N/A	DWS Contrast?	N/A
N/A	Landing Slope (%)	N/A	N/A	DWS Length (in)	N/A
N/A	Landing X Slope (%)	N/A	N/A	DWS Full Width?	N/A
N/A	Landing Curb? (Y/N)	N/A	N/A	DWS Offset (in)	N/A
N/A	Shared Landing?	N/A			
N/A	Gutter Ponding?	N/A	N/A	Gutter Slope (%)	N/A
N/A	Gutter Lip Ht (in)	N/A	N/A	Gutter X Slope (%)	N/A
N/A	Painted X Walk1?	No	N/A	Painted X Walk2?	No
	X Walk 1 Direction	To SE		X Walk 2 Direction	To N
N/A	X Walk 1 Width (in)	N/A	N/A	X Walk 2 Width (in)	N/A
	X Walk 1 Slope (%)	0.3		X Walk 2 Slope (%)	3.9

X Walk 1 X Slope (%)	4.8		X Walk 2 X Slope (%)	1.5
N/A	Ramp inside XWalk1?	N/A	N/A	Ramp inside XWalk2?	N/A
	Road Slope (%)	3.2	N/A	Clear Space?	N/A
	Road X Slope (%)	3.1	N/A	Clear Space to XWalk (in)	N/A
N/A	Any Obstructions?	N/A	N/A	Storm Grate/Utility Hazard?	N/A
	Obstruction Type			Storm Grate/Utility Type	
		N/A			N/A
			Yes	Surface Condition? (G/P)	Good

Remove & Replace Curb Ramp With Two New Directional Ramps or Equivalent.
