# Access Compliance Report
# Public Rights-of-Way
# (Curb Ramps)

| Intersection ID: 52931 | Main Street: WALTHAM_LN | Cross Street: GRAY_OAK_LN | Location: N |
| ADA ID: 4D8EDD5CA6DE | Ramp Type: Perp | Initial Pass/Fail: Pass | Overall Compliance: No | Severity Score: 0 |

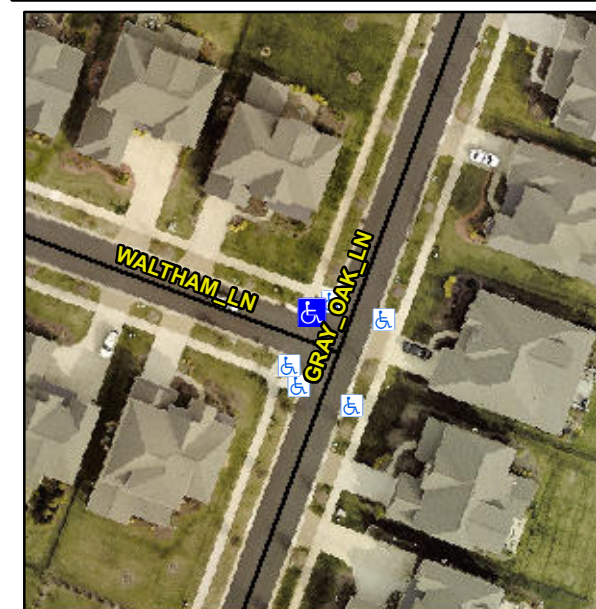
**PROW/ADA:**

**R304.5.3, R305.2**

| Compliance | Description | Data | Compliance | Description | Data |
|---|---|---|---|---|---|
| No | Landing X Slope (%) | 3.0 | Yes | DWS Full Width? | Yes |
| N/A | Landing Curb? (Y/N) | No | No | DWS Offset (in) | 5.0 |

**Remove & Replace Entire Ramp.**
