Access Compliance Report
Public Rights-of-Way
(Curb Ramps)

Intersection ID: 17550	Main Street: TANGLE_DR	Cross Street: WINDEMERE_LN	Location:	E
ADA ID: 4DEF41B141E8	Ramp Type: BlendTrans1	Initial Pass/Fail: Pass	Overall Compliance: No	Severity Score: 11.5

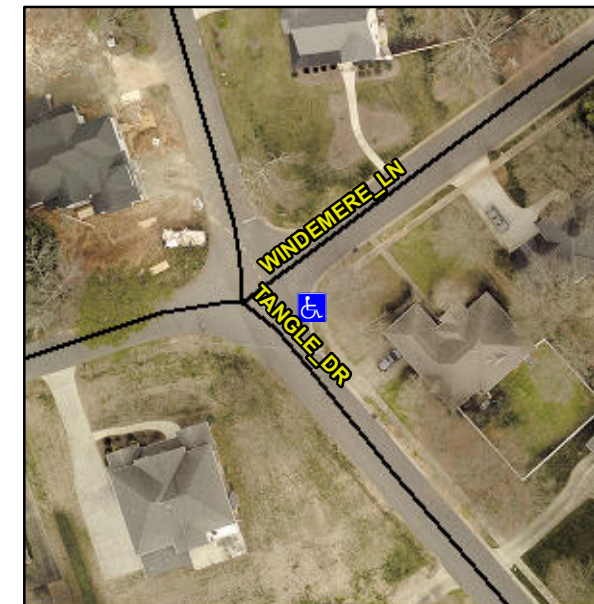
Not Found, R304.2.1, R305.1.4, R305.2, R304.5.4, R304.5.3

Compliance	Description	Data	Compliance	Description	Data
N/A	Ramp Length (in)	47.5	Yes	BlendTrans Slope (%)	3.0
Yes	Ramp Width (in)	48.0	Yes	BlendTrans XSlope (%)	0.9
N/A	Flare Type LT	Sloped	N/A	Flare Type RT	Sloped
N/A	Flare Slope LT (%)	N/A	N/A	Flare Slope RT (%)	N/A
N/A	Flare Traversable LT?	No	N/A	Flare Traversable RT?	No
No	Landing Length (in)	44.5	Yes	DWS Provided?	Yes
No	Landing Width (in)	46.5	Yes	DWS Contrast?	Yes
Yes	Landing Slope (%)	1.7	Yes	DWS Length (in)	25.5
Yes	Landing X Slope (%)	0.8	No	DWS Full Width?	No
N/A	Landing Curb? (Y/N)	No	No	DWS Offset (in)	4.0
N/A	Shared Landing?	No			
Yes	Gutter Ponding?	No	No	Gutter Slope (%)	8.1
Yes	Gutter Lip Ht (in)	0.0	No	Gutter X Slope (%)	4.2
N/A	Painted X Walk1?	No	N/A	Painted X Walk2?	No
	X Walk 1 Direction	To N		X Walk 2 Direction	To N
	X Walk 1 Width (in)	N/A		X Walk 2 Width (in)	N/A
	X Walk 1 Slope (%)	1.9		X Walk 2 Slope (%)	N/A
	X Walk 1 X Slope (%)	0.0		X Walk 2 X Slope (%)	N/A

N/A	Ramp inside XWalk1?	N/A	N/A	Ramp inside XWalk2?	N/A
	Road Slope (%)	0.0		Clear Space?	Yes
	Road X Slope (%)	1.9	N/A	Clear Space to XWalk (in)	N/A
Yes	Any Obstructions?	No	Yes	Storm Grate/Utility Hazard?	No
	Obstruction Type			Storm Grate/Utility Type	
N/A					N/A
			Yes	Surface Condition? (G/P)	Good
			No	Curb Slope (%)	11.8

Remove & Replace Curb Ramp With Two New Directional Ramps or Equivalent. Remove & Replace Gutter.
