Access Compliance Report
Public Rights-of-Way
(Curb Ramps)

Intersection ID: 49248	Main Street: BOOMERANG_WY	Cross Street: PROSPERITY_VIEW_DR	Location:	N
ADA ID: 4EC0DA9C8F21	Ramp Type: PerpDiag	Initial Pass/Fail: Fail	Overall Compliance: No	Severity Score: 10

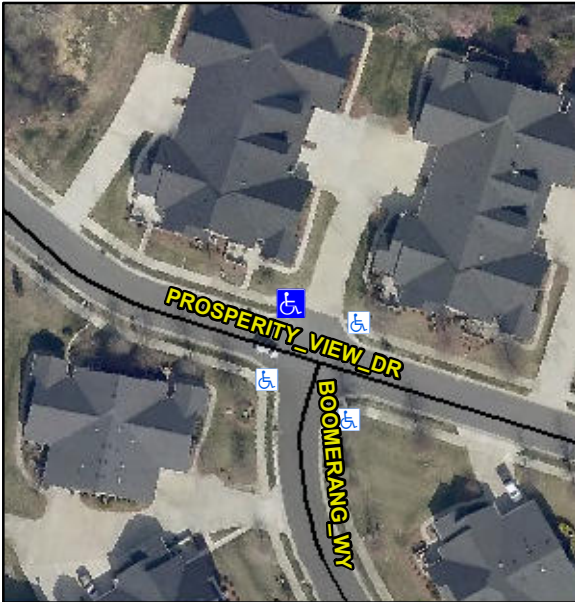
Not Found, R304.5.1, R304.5.3

Compliance	Description	Data	Compliance	Description	Data
N/A	Ramp Length (in)	48.0	Yes	Ramp Slope (%)	5.5
No	Ramp Width (in)	47.0	No	Ramp XSlope (%)	2.4
N/A	Flare Type LT	N/A	N/A	Flare Type RT	N/A
N/A	Flare Slope LT (%)	N/A	N/A	Flare Slope RT (%)	N/A
N/A	Flare Traversable LT?	N/A	N/A	Flare Traversable RT?	N/A
N/A	Landing Length (in)	N/A	N/A	DWS Provided?	N/A
N/A	Landing Width (in)	N/A	N/A	DWS Contrast?	N/A
N/A	Landing Slope (%)	N/A	N/A	DWS Length (in)	N/A
N/A	Landing X Slope (%)	N/A	N/A	DWS Full Width?	N/A
N/A	Landing Curb? (Y/N)	N/A	N/A	DWS Offset (in)	N/A
N/A	Shared Landing?	N/A			
N/A	Gutter Ponding?	N/A	N/A	Gutter Slope (%)	N/A
N/A	Gutter Lip Ht (in)	N/A	N/A	Gutter X Slope (%)	N/A
N/A	Painted X Walk1?	No	N/A	Painted X Walk2?	No
	X Walk 1 Direction	To SW		X Walk 2 Direction	To SE
N/A	X Walk 1 Width (in)	N/A	N/A	X Walk 2 Width (in)	N/A
	X Walk 1 Slope (%)	7.3		X Walk 2 Slope (%)	4.1
	X Walk 1 X Slope (%)	1.3		X Walk 2 X Slope (%)	1.2

Remove & Replace Curb Ramp With Two New Directional Ramps or Equivalent.
