Access Compliance Report
Public Rights-of-Way
(Curb Ramps)

Intersection ID: 15362	Main Street: MARNEY_AV	Cross Street: SKYLAND_AV	Location: E
ADA ID: 4F2134E09484	Ramp Type: PerpDiag	Initial Pass/Fail: Fail	Overall Compliance: No Severity Score: 36.25

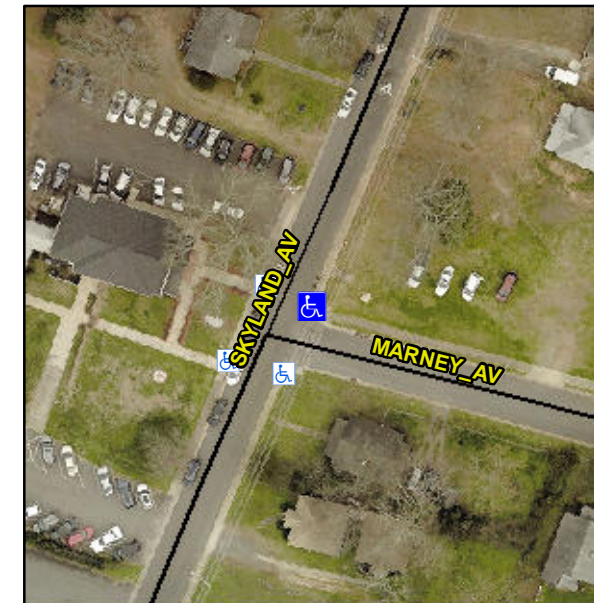
Not Found, R304.5.1, R304.5.3

Compliance	Description	Data	Compliance	Description	Data
N/A	Ramp Length (in)	55.0	Yes	Ramp Slope (%)	6.5
No	Ramp Width (in)	27.0	No	Ramp XSlope (%)	2.6
N/A	Flare Type LT	N/A	N/A	Flare Type RT	N/A
N/A	Flare Slope LT (%)	N/A	N/A	Flare Slope RT (%)	N/A
N/A	Flare Traversable LT?	N/A	N/A	Flare Traversable RT?	N/A
N/A	Landing Length (in)	N/A	N/A	DWS Provided?	N/A
N/A	Landing Width (in)	N/A	N/A	DWS Contrast?	N/A
N/A	Landing Slope (%)	N/A	N/A	DWS Length (in)	N/A
N/A	Landing X Slope (%)	N/A	N/A	DWS Full Width?	N/A
N/A	Landing Curb? (Y/N)	N/A	N/A	DWS Offset (in)	N/A
N/A	Shared Landing?	N/A			
N/A	Gutter Ponding?	N/A	N/A	Gutter Slope (%)	N/A
N/A	Gutter Lip Ht (in)	N/A	N/A	Gutter X Slope (%)	N/A
N/A	Painted X Walk1?	No	N/A	Painted X Walk2?	No
	X Walk 1 Direction	To NW		X Walk 2 Direction	To SW
N/A	X Walk 1 Width (in)	N/A	N/A	X Walk 2 Width (in)	N/A
	X Walk 1 Slope (%)	5.3		X Walk 2 Slope (%)	1.2
	X Walk 1 X Slope (%)	2.7		X Walk 2 X Slope (%)	1.7

Remove & Replace Curb Ramp With Two New Directional Ramps or Equivalent.
