Access Compliance Report
Public Rights-of-Way
(Curb Ramps)

Intersection ID: 46813	Main Street: ARBOR_VISTA_DR	Cross Street: OLDE_IVY_WY	Location:	SW
ADA ID: 4F40EC74A68C	Ramp Type: Perp	Initial Pass/Fail: Fail	Overall Compliance: No	Severity Score: 33.75

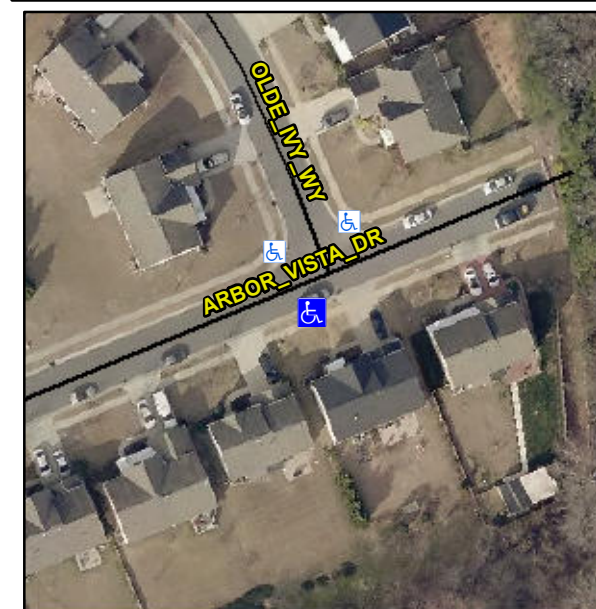
R304.5.1, R304.2.2

Compliance	Description	Data	Compliance	Description	Data
N/A	Ramp Length (in)	47.5	No	Ramp Slope (%)	12.0
No	Ramp Width (in)	45.5	Yes	Ramp XSlope (%)	0.8
N/A	Flare Type LT	N/A	N/A	Flare Type RT	N/A
N/A	Flare Slope LT (%)	N/A	N/A	Flare Slope RT (%)	N/A
N/A	Flare Traversable LT?	N/A	N/A	Flare Traversable RT?	N/A
N/A	Landing Length (in)	N/A	N/A	DWS Provided?	N/A
N/A	Landing Width (in)	N/A	N/A	DWS Contrast?	N/A
N/A	Landing Slope (%)	N/A	N/A	DWS Length (in)	N/A
N/A	Landing X Slope (%)	N/A	N/A	DWS Full Width?	N/A
N/A	Landing Curb? (Y/N)	N/A	N/A	DWS Offset (in)	N/A
N/A	Shared Landing?	N/A			
N/A	Gutter Ponding?	N/A	N/A	Gutter Slope (%)	N/A
N/A	Gutter Lip Ht (in)	N/A	N/A	Gutter X Slope (%)	N/A
N/A	Painted X Walk1?	No	N/A	Painted X Walk2?	N/A
	X Walk 1 Direction	To N		X Walk 2 Direction	N/A
N/A	X Walk 1 Width (in)	N/A	N/A	X Walk 2 Width (in)	N/A
	X Walk 1 Slope (%)	2.0		X Walk 2 Slope (%)	N/A
	X Walk 1 X Slope (%)	1.0		X Walk 2 X Slope (%)	N/A

Remove & Replace Entire Ramp.
