# Access Compliance Report
Public Rights-of-Way
(Curb Ramps)

Intersection ID: 10027126   **Main Street:** GARDEN_TR   **Cross Street:** N/A   **Location:** E

ADA ID: 4F5F820FE325   **Ramp Type:** Perp   **Initial Pass/Fail:** Fail   **Overall Compliance:** No   **Severity Score:** 12.5

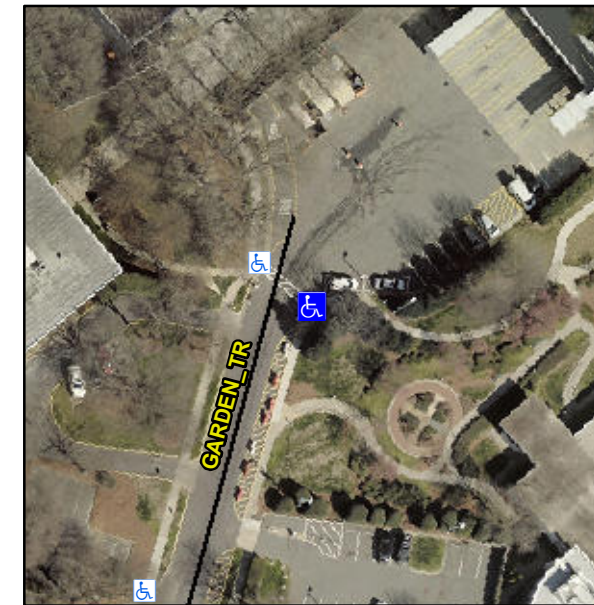
R304.5.3

Compliance	Description	Data	Compliance	Description	Data
N/A	Ramp Length (in)	64.0	Yes	Ramp Slope (%)	8.0
Yes	Ramp Width (in)	50.0	No	Ramp XSlope (%)	5.8
N/A	Flare Type LT	N/A	N/A	Flare Type RT	N/A
N/A	Flare Slope LT (%)	N/A	N/A	Flare Slope RT (%)	N/A
N/A	Flare Traversable LT?	N/A	N/A	Flare Traversable RT?	N/A
N/A	Landing Length (in)	N/A	N/A	DWS Provided?	N/A
N/A	Landing Width (in)	N/A	N/A	DWS Contrast?	N/A
N/A	Landing Slope (%)	N/A	N/A	DWS Length (in)	N/A
N/A	Landing X Slope (%)	N/A	N/A	DWS Full Width?	N/A
N/A	Landing Curb? (Y/N)	N/A	N/A	DWS Offset (in)	N/A
N/A	Shared Landing?	N/A			
N/A	Gutter Ponding?	N/A	N/A	Gutter Slope (%)	N/A
N/A	Gutter Lip Ht (in)	N/A	N/A	Gutter X Slope (%)	N/A
N/A	Painted X Walk1?	Yes	N/A	Painted X Walk2?	N/A
	X Walk 1 Direction	To NW		X Walk 2 Direction	N/A
N/A	X Walk 1 Width (in)	45.0	N/A	X Walk 2 Width (in)	N/A
	X Walk 1 Slope (%)	3.1		X Walk 2 Slope (%)	N/A
	X Walk 1 X Slope (%)	5.0		X Walk 2 X Slope (%)	N/A

Remove & Replace Entire Ramp.
