# Access Compliance Report
Public Rights-of-Way
(Curb Ramps)

Intersection ID: 10037026   **Main Street:** S_TRYON_ST   **Cross Street:** N/A   **Location:** N

ADA ID: 4F99DFBA07B5   **Ramp Type:** PerpDiag   **Initial Pass/Fail:** Fail   **Overall Compliance:** No   **Severity Score:** 46.25

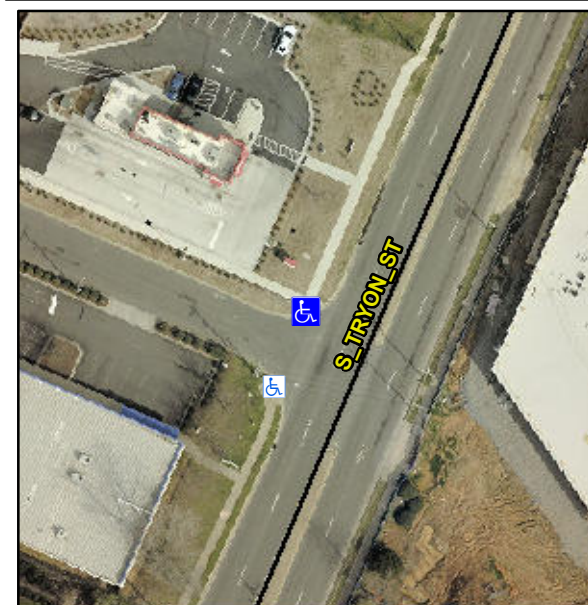
Not Found, R304.5.1, R304.2.2, R304.5.3

Compliance	Description	Data	Compliance	Description	Data
N/A	Ramp Length (in)	96.0	No	Ramp Slope (%)	11.0
No	Ramp Width (in)	36.0	No	Ramp XSlope (%)	7.3
N/A	Flare Type LT	N/A	N/A	Flare Type RT	N/A
N/A	Flare Slope LT (%)	N/A	N/A	Flare Slope RT (%)	N/A
N/A	Flare Traversable LT?	N/A	N/A	Flare Traversable RT?	N/A
N/A	Landing Length (in)	N/A	N/A	DWS Provided?	N/A
N/A	Landing Width (in)	N/A	N/A	DWS Contrast?	N/A
N/A	Landing Slope (%)	N/A	N/A	DWS Length (in)	N/A
N/A	Landing X Slope (%)	N/A	N/A	DWS Full Width?	N/A
N/A	Landing Curb? (Y/N)	N/A	N/A	DWS Offset (in)	N/A
N/A	Shared Landing?	N/A			
N/A	Gutter Ponding?	N/A	N/A	Gutter Slope (%)	N/A
N/A	Gutter Lip Ht (in)	N/A	N/A	Gutter X Slope (%)	N/A
N/A	Painted X Walk1?	No	N/A	Painted X Walk2?	No
	X Walk 1 Direction	To SE		X Walk 2 Direction	To SW
N/A	X Walk 1 Width (in)	N/A	N/A	X Walk 2 Width (in)	N/A
	X Walk 1 Slope (%)	8.6		X Walk 2 Slope (%)	2.0
	X Walk 1 X Slope (%)	0.2		X Walk 2 X Slope (%)	6.1

N/A	Ramp inside XWalk1?	N/A	N/A	Ramp inside XWalk2?	N/A
	Road Slope (%)	3.9	N/A	Clear Space?	N/A
	Road X Slope (%)	6.1	N/A	Clear Space to XWalk (in)	N/A
N/A	Any Obstructions?	N/A	N/A	Storm Grate/Utility Hazard?	N/A
	Obstruction Type			Storm Grate/Utility Type	
N/A					N/A
			Yes	Surface Condition? (G/P)	Good

Remove & Replace Curb Ramp With Two New Directional Ramps or Equivalent.
