Access Compliance Report
Public Rights-of-Way
(Curb Ramps)

Intersection ID: 5421	**Main Street: SUNSET_RD**	**Cross Street: OLD_STATESVILLE_RD**	**Location: N**
ADA ID: 4FE00652FBE5	**Ramp Type: BlendTrans1**	**Initial Pass/Fail: Pass** **Overall Compliance: No**	**Severity Score: 0**

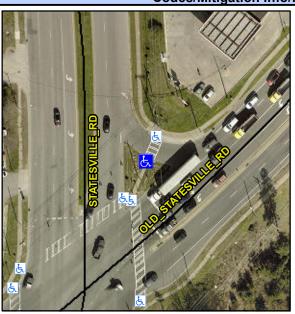
LOCATED ON ISLAND

Not Found, R304.2.1, R304.2.2-Perp, R304.3.2-Para, R302.7

Yes	Ramp inside XWalk1?	Yes	N/A	Ramp inside XWalk2?	N/A
	Road Slope (%)	1.5		Clear Space?	Yes
	Road X Slope (%)	1.2	N/A	Clear Space to XWalk (in)	N/A
Yes	Any Obstructions?	No	Yes	Storm Grate/Utility Hazard?	No
	Obstruction Type			Storm Grate/Utility Type	
N/A					N/A
			Yes	Surface Condition? (G/P)	Good
			No	Curb Slope (%)	11.8

Remove & Replace Curb Ramp With Two New Directional Ramps or Equivalent.
