# Access Compliance Report
Public Rights-of-Way
(Curb Ramps)

Intersection ID: 28180	Main Street: AUTUMN_APPLAUSE_DR	Cross Street: HUNTLAND_CT	Location:	NW
ADA ID: 50DECEED6CF6	Ramp Type: PerpDiag	Initial Pass/Fail: Fail	Overall Compliance: No	Severity Score: 36.25

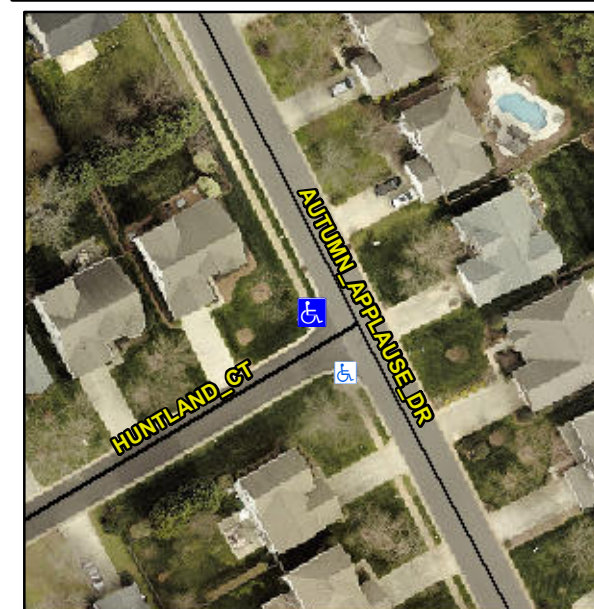
Not Found, R304.5.1, R304.5.3

Compliance	Description	Data	Compliance	Description	Data
N/A	Ramp Length (in)	96.0	Yes	Ramp Slope (%)	5.6
No	Ramp Width (in)	25.0	No	Ramp XSlope (%)	3.6
N/A	Flare Type LT	N/A	N/A	Flare Type RT	N/A
N/A	Flare Slope LT (%)	N/A	N/A	Flare Slope RT (%)	N/A
N/A	Flare Traversable LT?	N/A	N/A	Flare Traversable RT?	N/A
N/A	Landing Length (in)	N/A	N/A	DWS Provided?	N/A
N/A	Landing Width (in)	N/A	N/A	DWS Contrast?	N/A
N/A	Landing Slope (%)	N/A	N/A	DWS Length (in)	N/A
N/A	Landing X Slope (%)	N/A	N/A	DWS Full Width?	N/A
N/A	Landing Curb? (Y/N)	N/A	N/A	DWS Offset (in)	N/A
N/A	Shared Landing?	N/A			
N/A	Gutter Ponding?	N/A	N/A	Gutter Slope (%)	N/A
N/A	Gutter Lip Ht (in)	N/A	N/A	Gutter X Slope (%)	N/A
N/A	Painted X Walk1?	No	N/A	Painted X Walk2?	No
	X Walk 1 Direction	To SE		X Walk 2 Direction	To NE
N/A	X Walk 1 Width (in)	N/A	N/A	X Walk 2 Width (in)	N/A
	X Walk 1 Slope (%)	0.7		X Walk 2 Slope (%)	4.5
	X Walk 1 X Slope (%)	4.0		X Walk 2 X Slope (%)	0.4

N/A	Ramp inside XWalk1?	N/A	N/A	Ramp inside XWalk2?	N/A
	Road Slope (%)	4.4	N/A	Clear Space?	N/A
	Road X Slope (%)	1.8	N/A	Clear Space to XWalk (in)	N/A
N/A	Any Obstructions?	N/A	N/A	Storm Grate/Utility Hazard?	N/A
	Obstruction Type			Storm Grate/Utility Type	
N/A					N/A
			Yes	Surface Condition? (G/P)	Good

Remove & Replace Curb Ramp With Two New Directional Ramps or Equivalent.
