Access Compliance Report
Public Rights-of-Way
(Curb Ramps)

Intersection ID: 11051	Main Street: E_21ST_ST	Cross Street: N_BREVARD_ST	Location: E
ADA ID: 511410669757	Ramp Type: PerpDiag	Initial Pass/Fail: Fail	Overall Compliance: No	Severity Score: 22.5

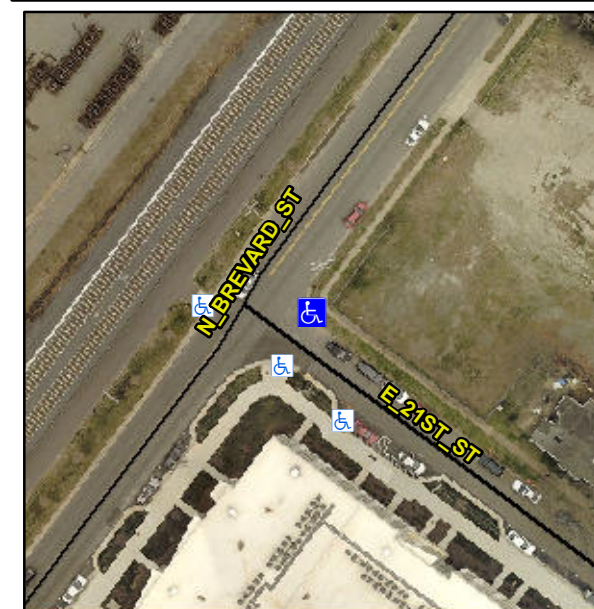
R304.5.1, R304.2.2, R304.5.3

Compliance	Description	Data	Compliance	Description	Data
N/A	Ramp Length (in)	53.0	No	Ramp Slope (%)	9.3
No	Ramp Width (in)	47.0	No	Ramp XSlope (%)	3.6
N/A	Flare Type LT	N/A	N/A	Flare Type RT	N/A
N/A	Flare Slope LT (%)	N/A	N/A	Flare Slope RT (%)	N/A
N/A	Flare Traversable LT?	N/A	N/A	Flare Traversable RT?	N/A
N/A	Landing Length (in)	N/A	N/A	DWS Provided?	N/A
N/A	Landing Width (in)	N/A	N/A	DWS Contrast?	N/A
N/A	Landing Slope (%)	N/A	N/A	DWS Length (in)	N/A
N/A	Landing X Slope (%)	N/A	N/A	DWS Full Width?	N/A
N/A	Landing Curb? (Y/N)	N/A	N/A	DWS Offset (in)	N/A
N/A	Shared Landing?	N/A			
N/A	Gutter Ponding?	N/A	N/A	Gutter Slope (%)	N/A
N/A	Gutter Lip Ht (in)	N/A	N/A	Gutter X Slope (%)	N/A
N/A	Painted X Walk1?	No	N/A	Painted X Walk2?	No
	X Walk 1 Direction	To NW		X Walk 2 Direction	To SW
N/A	X Walk 1 Width (in)	N/A	N/A	X Walk 2 Width (in)	N/A
	X Walk 1 Slope (%)	0.8		X Walk 2 Slope (%)	1.4
	X Walk 1 X Slope (%)	1.4		X Walk 2 X Slope (%)	0.3

Remove & Replace Curb Ramp With Two New Directional Ramps or Equivalent.
