Access Compliance Report
Public Rights-of-Way
(Curb Ramps)

Intersection ID: 16646	Main Street: ORCHARD_CR	Cross Street: S_TRYON_ST	Location: N
ADA ID: 51C9778B1D60	Ramp Type: PerpDiag	Initial Pass/Fail: Fail	Overall Compliance: No	Severity Score: 10

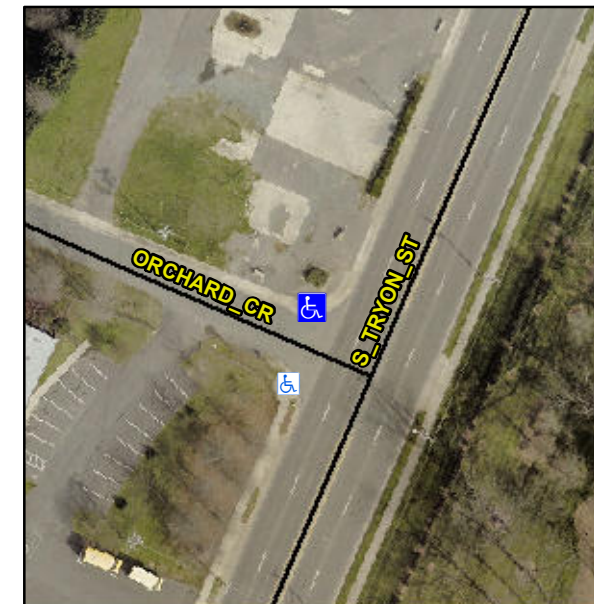
Not Found, R304.5.1, R304.5.3

Compliance	Description	Data	Compliance	Description	Data
N/A	Ramp Length (in)	63.0	Yes	Ramp Slope (%)	7.0
No	Ramp Width (in)	46.0	No	Ramp XSlope (%)	3.1
N/A	Flare Type LT	N/A	N/A	Flare Type RT	N/A
N/A	Flare Slope LT (%)	N/A	N/A	Flare Slope RT (%)	N/A
N/A	Flare Traversable LT?	N/A	N/A	Flare Traversable RT?	N/A
N/A	Landing Length (in)	N/A	N/A	DWS Provided?	N/A
N/A	Landing Width (in)	N/A	N/A	DWS Contrast?	N/A
N/A	Landing Slope (%)	N/A	N/A	DWS Length (in)	N/A
N/A	Landing X Slope (%)	N/A	N/A	DWS Full Width?	N/A
N/A	Landing Curb? (Y/N)	N/A	N/A	DWS Offset (in)	N/A
N/A	Shared Landing?	N/A			
N/A	Gutter Ponding?	N/A	N/A	Gutter Slope (%)	N/A
N/A	Gutter Lip Ht (in)	N/A	N/A	Gutter X Slope (%)	N/A
N/A	Painted X Walk1?	No	N/A	Painted X Walk2?	No
	X Walk 1 Direction	To SW		X Walk 2 Direction	To SE
N/A	X Walk 1 Width (in)	N/A	N/A	X Walk 2 Width (in)	N/A
	X Walk 1 Slope (%)	2.5		X Walk 2 Slope (%)	1.1
	X Walk 1 X Slope (%)	1.8		X Walk 2 X Slope (%)	0.6

Remove & Replace Curb Ramp With Two New Directional Ramps or Equivalent.
