# Access Compliance Report
Public Rights-of-Way
(Curb Ramps)

Intersection ID: 49135	Main Street: AMBER_LEIGH_WAY_DR	Cross Street: AMESBURY_HILL_DR	Location:	N
ADA ID: 52ED64116085	Ramp Type: PerpDiag	Initial Pass/Fail: Fail	Overall Compliance: No	Severity Score: 8.75

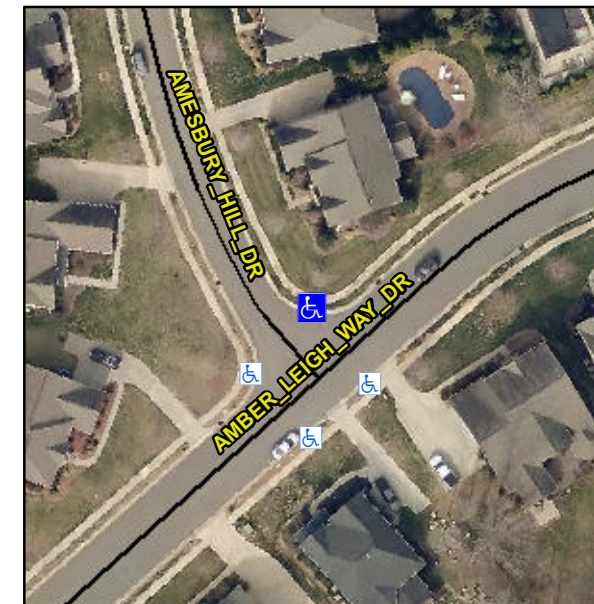
Not Found, R304.5.1

Compliance	Description	Data	Compliance	Description	Data
N/A	Ramp Length (in)	48.0	Yes	Ramp Slope (%)	5.3
No	Ramp Width (in)	46.0	Yes	Ramp XSlope (%)	1.6
N/A	Flare Type LT	N/A	N/A	Flare Type RT	N/A
N/A	Flare Slope LT (%)	N/A	N/A	Flare Slope RT (%)	N/A
N/A	Flare Traversable LT?	N/A	N/A	Flare Traversable RT?	N/A
N/A	Landing Length (in)	N/A	N/A	DWS Provided?	N/A
N/A	Landing Width (in)	N/A	N/A	DWS Contrast?	N/A
N/A	Landing Slope (%)	N/A	N/A	DWS Length (in)	N/A
N/A	Landing X Slope (%)	N/A	N/A	DWS Full Width?	N/A
N/A	Landing Curb? (Y/N)	N/A	N/A	DWS Offset (in)	N/A
N/A	Shared Landing?	N/A			
N/A	Gutter Ponding?	N/A	N/A	Gutter Slope (%)	N/A
N/A	Gutter Lip Ht (in)	N/A	N/A	Gutter X Slope (%)	N/A
N/A	Painted X Walk1?	No	N/A	Painted X Walk2?	No
	X Walk 1 Direction	To SW		X Walk 2 Direction	To SE
N/A	X Walk 1 Width (in)	N/A	N/A	X Walk 2 Width (in)	N/A
	X Walk 1 Slope (%)	2.0		X Walk 2 Slope (%)	0.7
	X Walk 1 X Slope (%)	1.6		X Walk 2 X Slope (%)	1.3

Remove & Replace Curb Ramp With Two New Directional Ramps or Equivalent.
