Access Compliance Report
Public Rights-of-Way
(Curb Ramps)

Intersection ID: 13595	Main Street: DEWBERRY_TR	Cross Street: DR_CARVER_RD	Location:	SE
ADA ID: 5316DDBA1333	Ramp Type: Perp	Initial Pass/Fail: Fail	Overall Compliance: No	Severity Score: 8.75

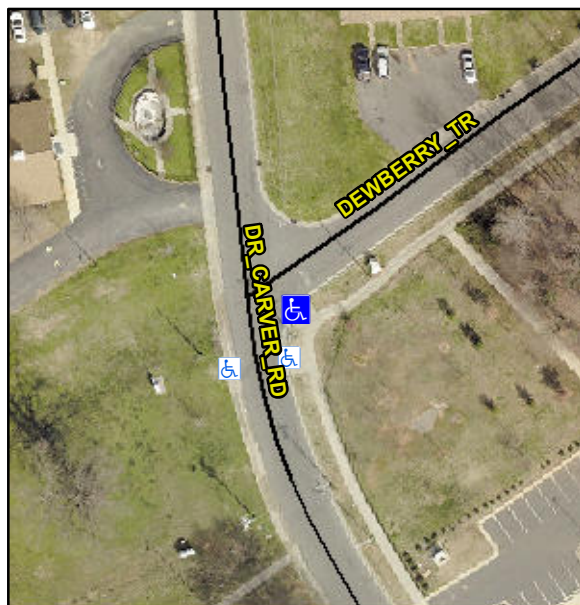
Not Found, R304.5.1

Compliance	Description	Data	Compliance	Description	Data
N/A	Ramp Length (in)	96.0	Yes	Ramp Slope (%)	6.2
No	Ramp Width (in)	47.0	Yes	Ramp XSlope (%)	0.7
N/A	Flare Type LT	N/A	N/A	Flare Type RT	N/A
N/A	Flare Slope LT (%)	N/A	N/A	Flare Slope RT (%)	N/A
N/A	Flare Traversable LT?	N/A	N/A	Flare Traversable RT?	N/A
N/A	Landing Length (in)	N/A	N/A	DWS Provided?	N/A
N/A	Landing Width (in)	N/A	N/A	DWS Contrast?	N/A
N/A	Landing Slope (%)	N/A	N/A	DWS Length (in)	N/A
N/A	Landing X Slope (%)	N/A	N/A	DWS Full Width?	N/A
N/A	Landing Curb? (Y/N)	N/A	N/A	DWS Offset (in)	N/A
N/A	Shared Landing?	N/A			
N/A	Gutter Ponding?	N/A	N/A	Gutter Slope (%)	N/A
N/A	Gutter Lip Ht (in)	N/A	N/A	Gutter X Slope (%)	N/A
N/A	Painted X Walk1?	No	N/A	Painted X Walk2?	N/A
	X Walk 1 Direction	To N		X Walk 2 Direction	N/A
N/A	X Walk 1 Width (in)	N/A	N/A	X Walk 2 Width (in)	N/A
	X Walk 1 Slope (%)	5.3		X Walk 2 Slope (%)	N/A
	X Walk 1 X Slope (%)	1.9		X Walk 2 X Slope (%)	N/A

Remove & Replace Entire Ramp.
