Access Compliance Report
Public Rights-of-Way
(Curb Ramps)

Intersection ID: 3032 | **Main Street:** FOX_GLEN_RD | **Cross Street:** FOX_HILL_DR | **Location:** SW

ADA ID: 539E3A0AE931 | **Ramp Type:** Directional1 | **Initial Pass/Fail:** Fail | **Overall Compliance:** No | **Severity Score:** 13.75

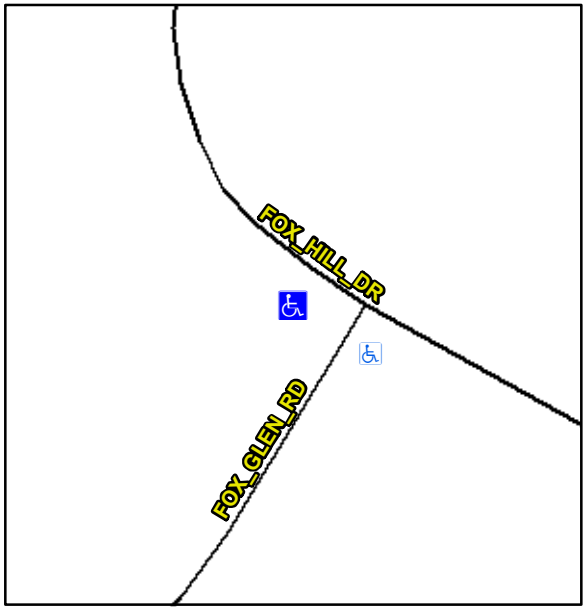
DAMAGED GTR/RAMP

R304.2.2, R304.5.3

Remove & Replace Entire Ramp.
