Access Compliance Report
Public Rights-of-Way
(Curb Ramps)

Intersection ID: 14797	Main Street: LYNDHURST_AV	Cross Street: MAGNOLIA_AV	Location: E
ADA ID: 550521EDD208	Ramp Type: Directional1	Initial Pass/Fail: Fail	Overall Compliance: No	Severity Score: 13.75

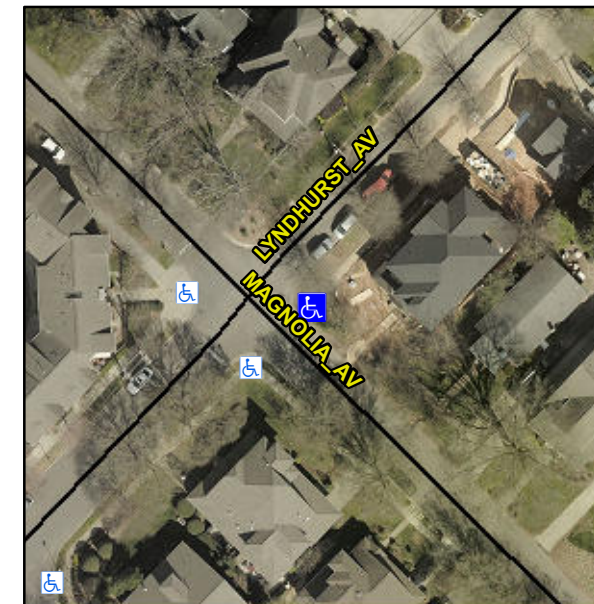
PROW/ADA:

R304.2.2, R304.5.3

Compliance	Description	Data	Compliance	Description	Data
N/A	Ramp Length (in)	108.0	N/A	Grade Break?	N/A
Yes	Ramp Width (in)	58.0	N/A	Grade Break Slope (%)	0.0
No	Ramp Slope (%)	10.0	N/A	Grade Break XSlope (%)	0.0
No	Ramp XSlope (%)	2.3			
N/A	Flare Type LT	N/A	N/A	Flare Type RT	N/A
N/A	Flare Slope LT (%)	N/A	N/A	Flare Slope RT (%)	0.0
N/A	Flare Traversable LT?	N/A	N/A	Flare Traversable RT?	N/A
N/A	Landing Length (in)	0.0	N/A	DWS Provided?	N/A
N/A	Landing Width (in)	0.0	N/A	DWS Contrast?	N/A
N/A	Landing Slope (%)	0.0	N/A	DWS Length (in)	N/A
N/A	Landing X Slope (%)	0.0	N/A	DWS Full Width?	N/A
N/A	Landing Curb? (Y/N)	N/A	N/A	DWS Offset LT (in)	N/A
N/A	Shared Landing?	N/A	N/A	DWS Offset RT (in)	N/A
N/A	Gutter Ponding?	0.0	N/A	Gutter Slope (%)	N/A
N/A	Gutter Lip Ht (in)	0.0	N/A	Gutter X Slope (%)	N/A
N/A	Painted X Walk1?	No		Road Slope (%)	3.1
	X Walk 1 Direction	To SW		Road X Slope (%)	1.4
	X Walk 1 Width (in)	N/A		Clear Space?	N/A

X Walk 1 Slope (%)	3.1	N/A	Clear Space to XWalk (in)	N/A
	X Walk 1 X Slope (%)	1.4	N/A	Storm Grate/Utility Hazard?	N/A
N/A	Ramp inside XWalk1?	N/A		Storm Grate/Utility Type	
N/A	Any Obstructions?	N/A			N/A
	Obstruction Type		Yes	Surface Condition? (G/P)	Good
N/A			N/A	Curb Slope (%)	3.4

Possible Solutions:

Remove & Replace Entire Ramp.

Total Cost:	$	1600.00
