Access Compliance Report
Public Rights-of-Way
(Curb Ramps)

Intersection ID: 24356 **Main Street:** BEVERLY_CREST_BV **Cross Street:** CAMAROSS_DR **Location:** W

ADA ID: 5517A32BD074 **Ramp Type:** Perp **Initial Pass/Fail:** Fail **Overall Compliance:** No **Severity Score:** 8.75

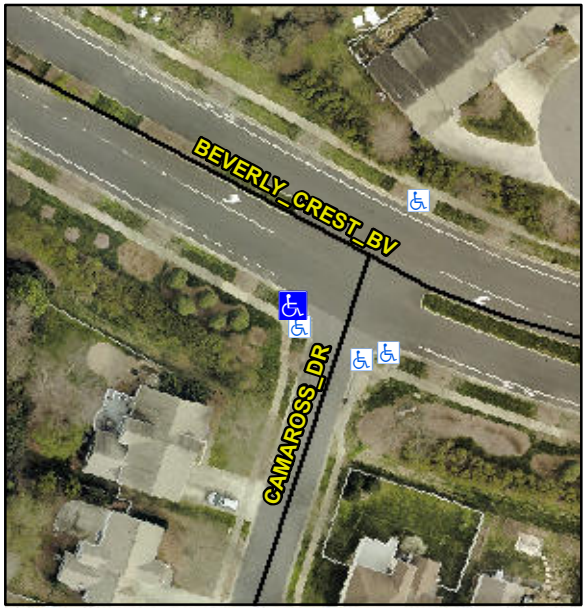
Not Found, R304.5.1

Compliance	Description	Data	Compliance	Description	Data
N/A	Ramp Length (in)	96.0	Yes	Ramp Slope (%)	8.2
No	Ramp Width (in)	40.0	Yes	Ramp XSlope (%)	0.2
N/A	Flare Type LT	N/A	N/A	Flare Type RT	N/A
N/A	Flare Slope LT (%)	N/A	N/A	Flare Slope RT (%)	N/A
N/A	Flare Traversable LT?	N/A	N/A	Flare Traversable RT?	N/A
N/A	Landing Length (in)	N/A	N/A	DWS Provided?	N/A
N/A	Landing Width (in)	N/A	N/A	DWS Contrast?	N/A
N/A	Landing Slope (%)	N/A	N/A	DWS Length (in)	N/A
N/A	Landing X Slope (%)	N/A	N/A	DWS Full Width?	N/A
N/A	Landing Curb? (Y/N)	N/A	N/A	DWS Offset (in)	N/A
N/A	Shared Landing?	N/A			
N/A	Gutter Ponding?	N/A	N/A	Gutter Slope (%)	N/A
N/A	Gutter Lip Ht (in)	N/A	N/A	Gutter X Slope (%)	N/A
N/A	Painted X Walk1?	No	N/A	Painted X Walk2?	N/A
	X Walk 1 Direction	To NE		X Walk 2 Direction	N/A
N/A	X Walk 1 Width (in)	N/A	N/A	X Walk 2 Width (in)	N/A
	X Walk 1 Slope (%)	1.5		X Walk 2 Slope (%)	N/A
	X Walk 1 X Slope (%)	1.3		X Walk 2 X Slope (%)	N/A

Remove & Replace Entire Ramp.
