Access Compliance Report
Public Rights-of-Way
(Curb Ramps)

Intersection ID: 5104	**Main Street:** E_MALLARD_CREEK_CHURCH_RD	**Cross Street:** MARY_ALEXANDER_RD	**Location:** S
ADA ID: 552C5D244A2C	**Ramp Type:** Perp	**Initial Pass/Fail:** Fail	**Overall Compliance:** No	**Severity Score:** 33.75

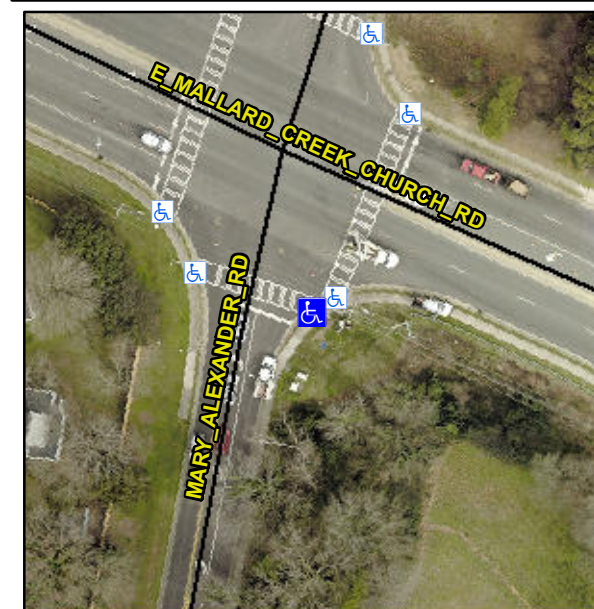
R304.5.1, R304.5.3

Compliance	Description	Data	Compliance	Description	Data
N/A	Ramp Length (in)	70.0	Yes	Ramp Slope (%)	7.7
No	Ramp Width (in)	47.0	No	Ramp XSlope (%)	13.0
N/A	Flare Type LT	N/A	N/A	Flare Type RT	N/A
N/A	Flare Slope LT (%)	N/A	N/A	Flare Slope RT (%)	N/A
N/A	Flare Traversable LT?	N/A	N/A	Flare Traversable RT?	N/A
N/A	Landing Length (in)	N/A	N/A	DWS Provided?	N/A
N/A	Landing Width (in)	N/A	N/A	DWS Contrast?	N/A
N/A	Landing Slope (%)	N/A	N/A	DWS Length (in)	N/A
N/A	Landing X Slope (%)	N/A	N/A	DWS Full Width?	N/A
N/A	Landing Curb? (Y/N)	N/A	N/A	DWS Offset (in)	N/A
N/A	Shared Landing?	N/A			
N/A	Gutter Ponding?	N/A	N/A	Gutter Slope (%)	N/A
N/A	Gutter Lip Ht (in)	N/A	N/A	Gutter X Slope (%)	N/A
N/A	Painted X Walk1?	Yes	N/A	Painted X Walk2?	N/A
	X Walk 1 Direction	To NW		X Walk 2 Direction	N/A
N/A	X Walk 1 Width (in)	109.0	N/A	X Walk 2 Width (in)	N/A
	X Walk 1 Slope (%)	4.4		X Walk 2 Slope (%)	N/A
	X Walk 1 X Slope (%)	10.5		X Walk 2 X Slope (%)	N/A

Remove & Replace Entire Ramp.
