# Access Compliance Report
Public Rights-of-Way
(Curb Ramps)

Intersection ID: N/A	Main Street: BLYTHNE_BV	Cross Street: N/A	Location:	SW
ADA ID: 5578B3562512	Ramp Type: PerpDiag	Initial Pass/Fail: Fail	Overall Compliance: No	Severity Score: 48.75

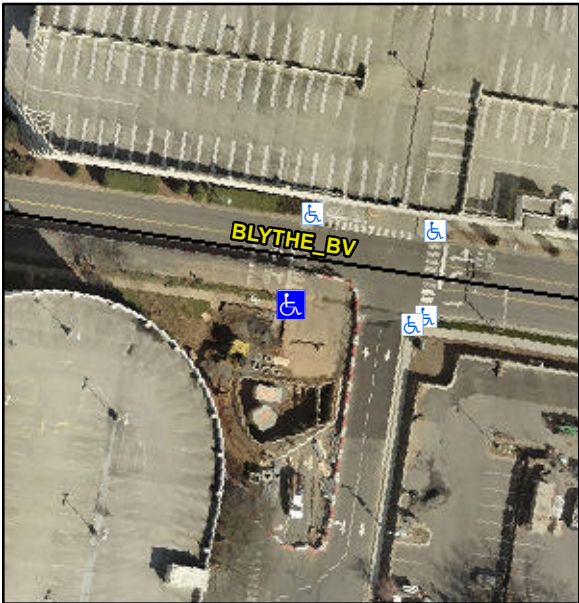
Not Found, R304.5.1, R304.2.2, R304.5.3

Compliance	Description	Data	Compliance	Description	Data
N/A	Ramp Length (in)	80.0	No	Ramp Slope (%)	8.7
No	Ramp Width (in)	26.0	No	Ramp XSlope (%)	3.3
N/A	Flare Type LT	N/A	N/A	Flare Type RT	N/A
N/A	Flare Slope LT (%)	N/A	N/A	Flare Slope RT (%)	N/A
N/A	Flare Traversable LT?	N/A	N/A	Flare Traversable RT?	N/A
N/A	Landing Length (in)	N/A	N/A	DWS Provided?	N/A
N/A	Landing Width (in)	N/A	N/A	DWS Contrast?	N/A
N/A	Landing Slope (%)	N/A	N/A	DWS Length (in)	N/A
N/A	Landing X Slope (%)	N/A	N/A	DWS Full Width?	N/A
N/A	Landing Curb? (Y/N)	N/A	N/A	DWS Offset (in)	N/A
N/A	Shared Landing?	N/A			
N/A	Gutter Ponding?	N/A	N/A	Gutter Slope (%)	N/A
N/A	Gutter Lip Ht (in)	N/A	N/A	Gutter X Slope (%)	N/A
N/A	Painted X Walk1?	Yes	N/A	Painted X Walk2?	Yes
	X Walk 1 Direction	To E		X Walk 2 Direction	To N
N/A	X Walk 1 Width (in)	74.0	N/A	X Walk 2 Width (in)	76.0
	X Walk 1 Slope (%)	3.8		X Walk 2 Slope (%)	3.1
	X Walk 1 X Slope (%)	5.5		X Walk 2 X Slope (%)	0.9

Remove & Replace Curb Ramp With Two New Directional Ramps or Equivalent.
