Access Compliance Report
Public Rights-of-Way
(Curb Ramps)

Intersection ID: 7001	**Main Street: MCALLISTER_DR**	**Cross Street: CRICKETEER_DR**	**Location: SE**
ADA ID: 56676EFE2468	**Ramp Type: Perp**	**Initial Pass/Fail: Fail**	**Overall Compliance: No** / **Severity Score: 37.5**

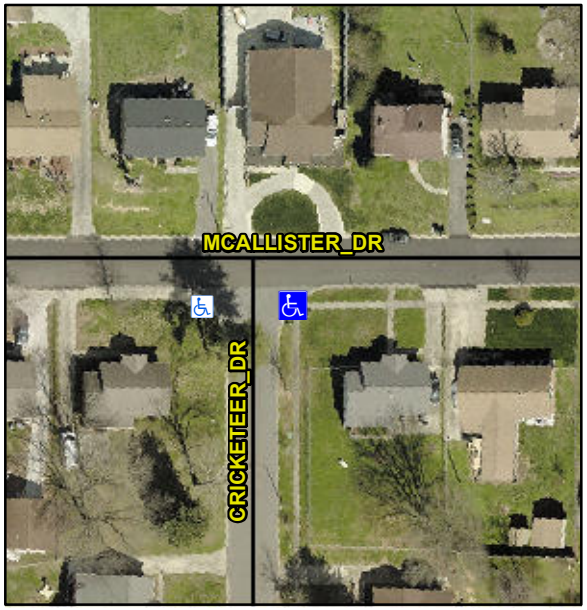
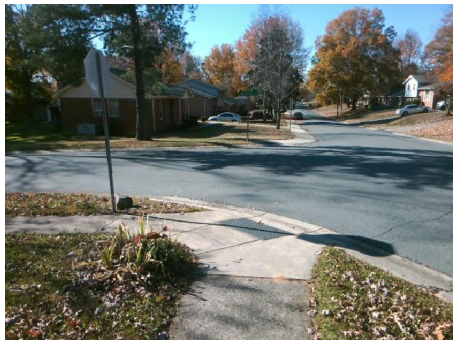
Not Found, R304.2.2, R304.5.3

Compliance	Description	Data	Compliance	Description	Data
N/A	Ramp Length (in)	25.0	No	Ramp Slope (%)	9.3
Yes	Ramp Width (in)	48.0	No	Ramp XSlope (%)	9.2
N/A	Flare Type LT	N/A	N/A	Flare Type RT	N/A
N/A	Flare Slope LT (%)	N/A	N/A	Flare Slope RT (%)	N/A
N/A	Flare Traversable LT?	N/A	N/A	Flare Traversable RT?	N/A
N/A	Landing Length (in)	N/A	N/A	DWS Provided?	N/A
N/A	Landing Width (in)	N/A	N/A	DWS Contrast?	N/A
N/A	Landing Slope (%)	N/A	N/A	DWS Length (in)	N/A
N/A	Landing X Slope (%)	N/A	N/A	DWS Full Width?	N/A
N/A	Landing Curb? (Y/N)	N/A	N/A	DWS Offset (in)	N/A
N/A	Shared Landing?	N/A			
N/A	Gutter Ponding?	N/A	N/A	Gutter Slope (%)	N/A
N/A	Gutter Lip Ht (in)	N/A	N/A	Gutter X Slope (%)	N/A
N/A	Painted X Walk1?	No	N/A	Painted X Walk2?	N/A
	X Walk 1 Direction	To W		X Walk 2 Direction	N/A
N/A	X Walk 1 Width (in)	N/A	N/A	X Walk 2 Width (in)	N/A
	X Walk 1 Slope (%)	1.8		X Walk 2 Slope (%)	N/A

X Walk 1 X Slope (%)	5.5		X Walk 2 X Slope (%)	N/A
N/A	Ramp inside XWalk1?	N/A	N/A	Ramp inside XWalk2?	N/A
	Road Slope (%)	N/A	N/A	Clear Space?	N/A
	Road X Slope (%)	N/A	N/A	Clear Space to XWalk (in)	N/A
N/A	Any Obstructions?	N/A	N/A	Storm Grate/Utility Hazard?	N/A
	Obstruction Type			Storm Grate/Utility Type	
		N/A			N/A
			Yes	Surface Condition? (G/P)	Good

Remove & Replace Entire Ramp.
