Access Compliance Report
Public Rights-of-Way
(Curb Ramps)

Intersection ID: 3125	Main Street: JOHNSTON_OEHLER_RD	Cross Street: MOURNING_DOVE_LN	Location: NE
ADA ID: 56CC3640D913	Ramp Type: PerpDiag	Initial Pass/Fail: Fail	Overall Compliance: No	Severity Score: 26.25

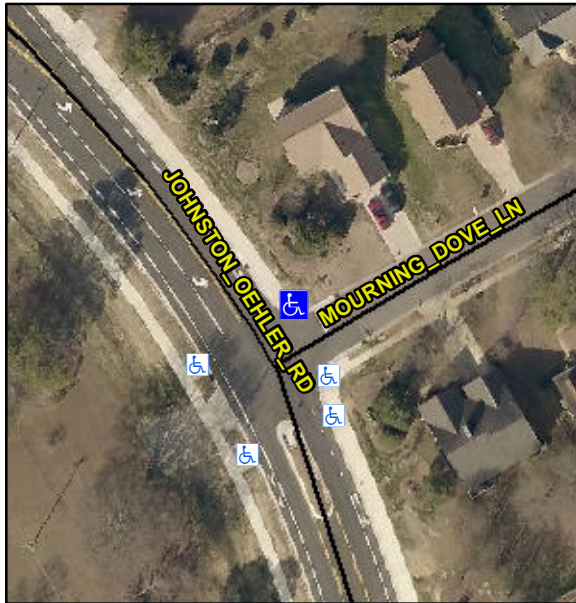
R304.2.2, R304.5.3

Compliance	Description	Data	Compliance	Description	Data
N/A	Ramp Length (in)	90.0	No	Ramp Slope (%)	13.1
Yes	Ramp Width (in)	48.0	No	Ramp XSlope (%)	2.2
N/A	Flare Type LT	N/A	N/A	Flare Type RT	N/A
N/A	Flare Slope LT (%)	N/A	N/A	Flare Slope RT (%)	N/A
N/A	Flare Traversable LT?	N/A	N/A	Flare Traversable RT?	N/A
N/A	Landing Length (in)	N/A	N/A	DWS Provided?	N/A
N/A	Landing Width (in)	N/A	N/A	DWS Contrast?	N/A
N/A	Landing Slope (%)	N/A	N/A	DWS Length (in)	N/A
N/A	Landing X Slope (%)	N/A	N/A	DWS Full Width?	N/A
N/A	Landing Curb? (Y/N)	N/A	N/A	DWS Offset (in)	N/A
N/A	Shared Landing?	N/A			
N/A	Gutter Ponding?	N/A	N/A	Gutter Slope (%)	N/A
N/A	Gutter Lip Ht (in)	N/A	N/A	Gutter X Slope (%)	N/A
N/A	Painted X Walk1?	No	N/A	Painted X Walk2?	No
	X Walk 1 Direction	To W		X Walk 2 Direction	To S
N/A	X Walk 1 Width (in)	N/A	N/A	X Walk 2 Width (in)	N/A
	X Walk 1 Slope (%)	0.1		X Walk 2 Slope (%)	2.4
	X Walk 1 X Slope (%)	2.6		X Walk 2 X Slope (%)	0.4

Remove & Replace Curb Ramp With Two New Directional Ramps or Equivalent.
