Access Compliance Report
Public Rights-of-Way
(Curb Ramps)

Intersection ID: 12150	Main Street: W_MARTIN_LUTHER_KING_JR_BV	Cross Street: S_GRAHAM_ST	Location:	N
ADA ID: 5773415B176D	Ramp Type: Perp	Initial Pass/Fail: Fail	Overall Compliance: No	Severity Score: 13.75

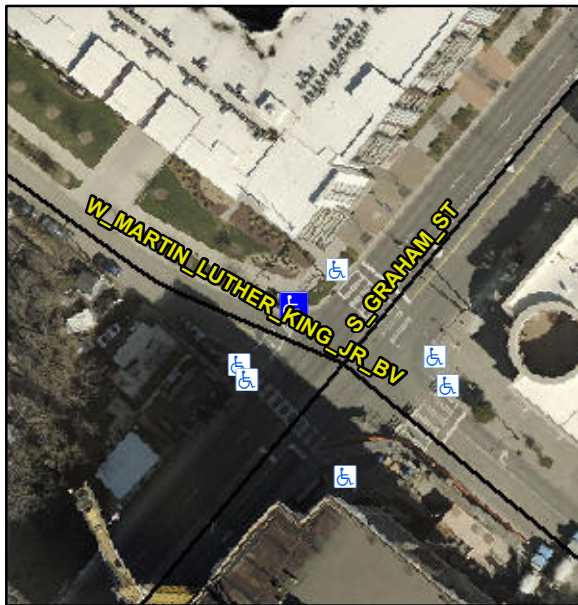
R304.2.2

Compliance	Description	Data	Compliance	Description	Data
N/A	Ramp Length (in)	70.0	No	Ramp Slope (%)	9.4
Yes	Ramp Width (in)	60.0	Yes	Ramp XSlope (%)	2.1
N/A	Flare Type LT	N/A	N/A	Flare Type RT	N/A
N/A	Flare Slope LT (%)	N/A	N/A	Flare Slope RT (%)	N/A
N/A	Flare Traversable LT?	N/A	N/A	Flare Traversable RT?	N/A
N/A	Landing Length (in)	N/A	N/A	DWS Provided?	N/A
N/A	Landing Width (in)	N/A	N/A	DWS Contrast?	N/A
N/A	Landing Slope (%)	N/A	N/A	DWS Length (in)	N/A
N/A	Landing X Slope (%)	N/A	N/A	DWS Full Width?	N/A
N/A	Landing Curb? (Y/N)	N/A	N/A	DWS Offset (in)	N/A
N/A	Shared Landing?	N/A			
N/A	Gutter Ponding?	N/A	N/A	Gutter Slope (%)	N/A
N/A	Gutter Lip Ht (in)	N/A	N/A	Gutter X Slope (%)	N/A
N/A	Painted X Walk1?	Yes	N/A	Painted X Walk2?	N/A
	X Walk 1 Direction	To SW		X Walk 2 Direction	N/A
N/A	X Walk 1 Width (in)	107.0	N/A	X Walk 2 Width (in)	N/A
	X Walk 1 Slope (%)	2.6		X Walk 2 Slope (%)	N/A
	X Walk 1 X Slope (%)	5.8		X Walk 2 X Slope (%)	N/A

Remove & Replace Entire Ramp.
