Access Compliance Report

# Public Rights-of-Way
(Curb Ramps)

Intersection ID: N/A	Main Street: ADA_CT	Cross Street: CALDWELL_RDGE_PY	Location:	S
ADA ID: 57904DDAE8DC	Ramp Type: Combination2Diag	Initial Pass/Fail: Fail	Overall Compliance: No	Severity Score: 0

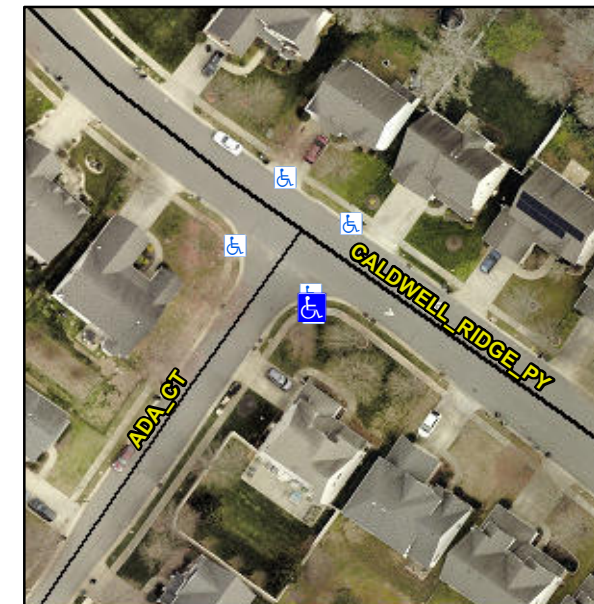
Not Found, R304.5.1, R304.5.1, R304.5.3

Compliance	Description	Data	Compliance	Description	Data
N/A	Ramp Length LT (in)	47.5	N/A	Ramp Length RT (in)	47.0
No	Ramp Width LT (in)	47.0	No	Ramp Width RT (in)	47.0
Yes	Ramp Slope LT (%)	3.1	Yes	Ramp Slope RT (%)	5.6
No	Ramp XSlope LT (%)	5.1	No	Ramp XSlope RT (%)	6.2
N/A	Ramp Length (in)	45.0	Yes	Ramp Slope (%)	0.3
No	Ramp Width (in)	47.0	No	Ramp XSlope (%)	2.9
N/A	Flare Type LT	N/A	N/A	Flare Type RT	N/A
N/A	Flare Slope LT (%)	N/A	N/A	Flare Slope RT (%)	N/A
N/A	Flare Traversable LT?	N/A	N/A	Flare Traversable RT?	N/A
N/A	Landing Length (in)	N/A	N/A	DWS Provided?	N/A
N/A	Landing Width (in)	N/A	N/A	DWS Contrast?	N/A
N/A	Landing Slope (%)	N/A	N/A	DWS Length (in)	N/A
N/A	Landing X Slope (%)	N/A	N/A	DWS Full Width?	N/A
N/A	Landing Curb? (Y/N)	N/A	N/A	DWS Offset (in)	N/A
N/A	Shared Landing?	N/A			
N/A	Gutter Ponding?	N/A	N/A	Gutter Slope (%)	N/A
N/A	Gutter Lip Ht (in)	N/A	N/A	Gutter X Slope (%)	N/A
N/A	Painted X Walk1?	No	N/A	Painted X Walk2?	No

Remove & Replace Curb Ramp With Two New Directional Ramps or Equivalent.
