Access Compliance Report

# Public Rights-of-Way
(Curb Ramps)

Intersection ID: 48587	Main Street: STONEY_CREEK_LN	Cross Street: UNIVERSITY_CITY_BV	Location:	SE
ADA ID: 58B4A9E4C674	Ramp Type: Combination1	Initial Pass/Fail: Fail	Overall Compliance: No	Severity Score: 8.75

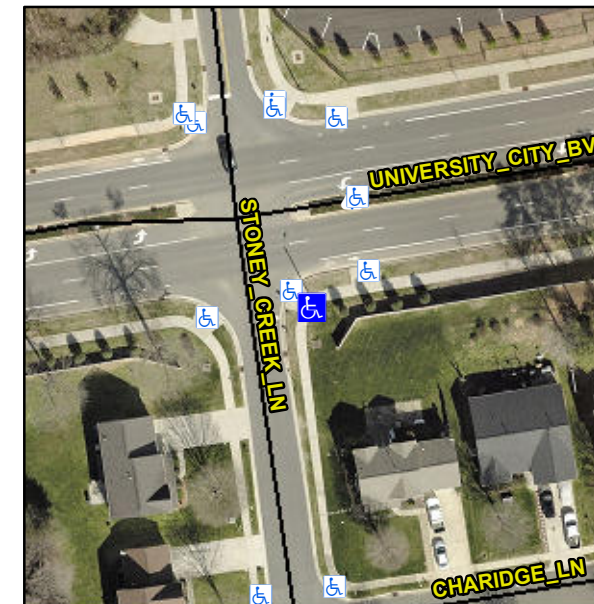
LT RP < 5%, RT RP < 5%

Not Found, R304.5.1

Compliance	Description	Data	Compliance	Description	Data
N/A	Ramp Length LT (in)	25.0	N/A	Ramp Length RT (in)	22.0
Yes	Ramp Width LT (in)	67.0	Yes	Ramp Width RT (in)	62.0
Yes	Ramp Slope LT (%)	2.0	Yes	Ramp Slope RT (%)	2.8
Yes	Ramp XSlope LT (%)	1.2	Yes	Ramp XSlope RT (%)	0.3
N/A	Ramp Length (in)	101.0	Yes	Ramp Slope (%)	4.1
No	Ramp Width (in)	44.5	Yes	Ramp XSlope (%)	1.5
N/A	Flare Type LT	N/A	N/A	Flare Type RT	N/A
N/A	Flare Slope LT (%)	N/A	N/A	Flare Slope RT (%)	N/A
N/A	Flare Traversable LT?	N/A	N/A	Flare Traversable RT?	N/A
N/A	Landing Length (in)	N/A	N/A	DWS Provided?	N/A
N/A	Landing Width (in)	N/A	N/A	DWS Contrast?	N/A
N/A	Landing Slope (%)	N/A	N/A	DWS Length (in)	N/A
N/A	Landing X Slope (%)	N/A	N/A	DWS Full Width?	N/A
N/A	Landing Curb? (Y/N)	N/A	N/A	DWS Offset (in)	N/A
N/A	Shared Landing?	N/A			
N/A	Gutter Ponding?	N/A	N/A	Gutter Slope (%)	N/A
N/A	Gutter Lip Ht (in)	N/A	N/A	Gutter X Slope (%)	N/A
N/A	Painted X Walk1?	No	N/A	Painted X Walk2?	N/A

X Walk 1 Direction	To W		X Walk 2 Direction	N/A
	X Walk 1 Width (in)	N/A		X Walk 2 Width (in)	N/A
	X Walk 1 Slope (%)	0.5		X Walk 2 Slope (%)	N/A
	X Walk 1 X Slope (%)	3.8		X Walk 2 X Slope (%)	N/A
N/A	Ramp inside XWalk1?	N/A	N/A	Ramp inside XWalk2?	N/A
	Road Slope (%)	N/A		Clear Space?	N/A
	Road X Slope (%)	N/A	N/A	Clear Space to XWalk (in)	N/A
			N/A	Any Obstruction?	N/A
				Obstruction Type	N/A
			N/A	Storm Grate/Utility Hazard?	N/A
				Storm Grate/Utility Type	N/A
			Yes	Surface Condition? (G/P)	Good
				Curb Slope (%)	7.6

Remove & Replace Entire Ramp.
