Access Compliance Report
Public Rights-of-Way
(Curb Ramps)

Intersection ID: 11685	Main Street: E_19TH_ST	Cross Street: SEIGLE_AV	Location:	E
ADA ID: 58CAFDFCF8EA	Ramp Type: Perp	Initial Pass/Fail: Fail	Overall Compliance: No	Severity Score: 10

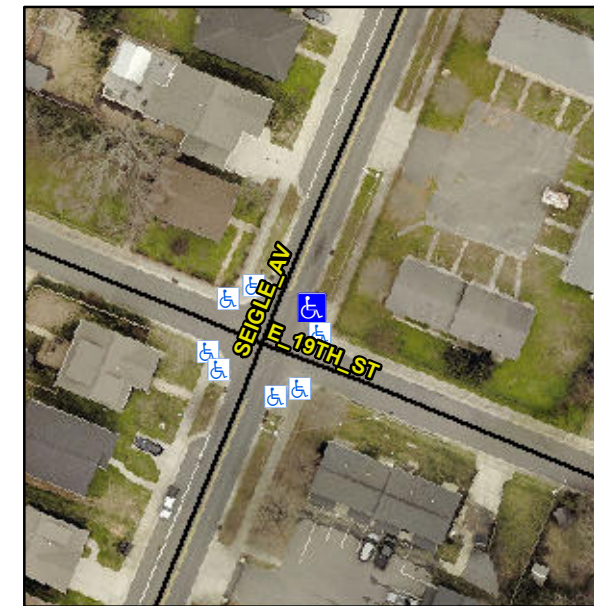
Not Found, R304.5.1, R304.5.3

Compliance	Description	Data	Compliance	Description	Data
N/A	Ramp Length (in)	74.0	Yes	Ramp Slope (%)	7.3
No	Ramp Width (in)	47.5	No	Ramp XSlope (%)	2.8
N/A	Flare Type LT	N/A	N/A	Flare Type RT	N/A
N/A	Flare Slope LT (%)	N/A	N/A	Flare Slope RT (%)	N/A
N/A	Flare Traversable LT?	N/A	N/A	Flare Traversable RT?	N/A
N/A	Landing Length (in)	N/A	N/A	DWS Provided?	N/A
N/A	Landing Width (in)	N/A	N/A	DWS Contrast?	N/A
N/A	Landing Slope (%)	N/A	N/A	DWS Length (in)	N/A
N/A	Landing X Slope (%)	N/A	N/A	DWS Full Width?	N/A
N/A	Landing Curb? (Y/N)	N/A	N/A	DWS Offset (in)	N/A
N/A	Shared Landing?	N/A			
N/A	Gutter Ponding?	N/A	N/A	Gutter Slope (%)	N/A
N/A	Gutter Lip Ht (in)	N/A	N/A	Gutter X Slope (%)	N/A
N/A	Painted X Walk1?	No	N/A	Painted X Walk2?	N/A
	X Walk 1 Direction	To NW		X Walk 2 Direction	N/A
N/A	X Walk 1 Width (in)	N/A	N/A	X Walk 2 Width (in)	N/A
	X Walk 1 Slope (%)	1.0		X Walk 2 Slope (%)	N/A
	X Walk 1 X Slope (%)	1.7		X Walk 2 X Slope (%)	N/A

Remove & Replace Entire Ramp.
