Access Compliance Report
Public Rights-of-Way
(Curb Ramps)

Intersection ID: 46481	Main Street: REVENNA_LN	Cross Street: BERKELEY_PLACE_DR	Location:	W
ADA ID: 59BE1C1BF4B0	Ramp Type: PerpDiag	Initial Pass/Fail: Fail	Overall Compliance: No	Severity Score: 13.75

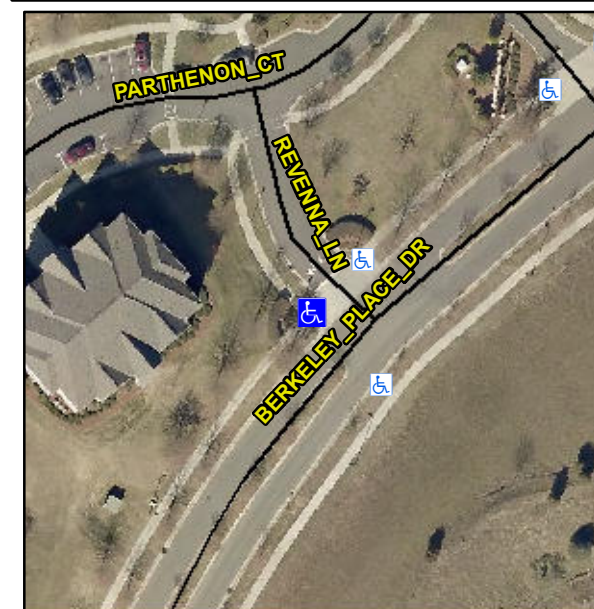
R304.2.2, R304.5.3

Compliance	Description	Data	Compliance	Description	Data
N/A	Ramp Length (in)	85.0	No	Ramp Slope (%)	9.0
Yes	Ramp Width (in)	61.0	No	Ramp XSlope (%)	3.6
N/A	Flare Type LT	N/A	N/A	Flare Type RT	N/A
N/A	Flare Slope LT (%)	N/A	N/A	Flare Slope RT (%)	N/A
N/A	Flare Traversable LT?	N/A	N/A	Flare Traversable RT?	N/A
N/A	Landing Length (in)	N/A	N/A	DWS Provided?	N/A
N/A	Landing Width (in)	N/A	N/A	DWS Contrast?	N/A
N/A	Landing Slope (%)	N/A	N/A	DWS Length (in)	N/A
N/A	Landing X Slope (%)	N/A	N/A	DWS Full Width?	N/A
N/A	Landing Curb? (Y/N)	N/A	N/A	DWS Offset (in)	N/A
N/A	Shared Landing?	N/A			
N/A	Gutter Ponding?	N/A	N/A	Gutter Slope (%)	N/A
N/A	Gutter Lip Ht (in)	N/A	N/A	Gutter X Slope (%)	N/A
N/A	Painted X Walk1?	No	N/A	Painted X Walk2?	No
	X Walk 1 Direction	To SE		X Walk 2 Direction	To NE
N/A	X Walk 1 Width (in)	N/A	N/A	X Walk 2 Width (in)	N/A
	X Walk 1 Slope (%)	0.8		X Walk 2 Slope (%)	3.1
	X Walk 1 X Slope (%)	3.1		X Walk 2 X Slope (%)	2.0

Remove & Replace Curb Ramp With Two New Directional Ramps or Equivalent.
