Access Compliance Report
Public Rights-of-Way
(Curb Ramps)

Intersection ID: 10033945	**Main Street: PARK_RD**	**Cross Street: N/A**	**Location: SW**
ADA ID: 5AEF111C783F	**Ramp Type: Perp**	**Initial Pass/Fail: Fail** **Overall Compliance: No**	**Severity Score: 12.5**

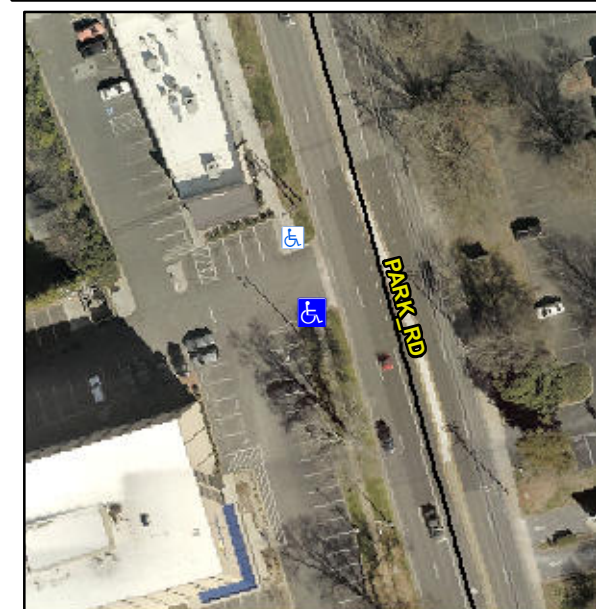
R304.2.2

Compliance	Description	Data	Compliance	Description	Data
N/A	Ramp Length (in)	120.0	No	Ramp Slope (%)	10.5
Yes	Ramp Width (in)	48.0	Yes	Ramp XSlope (%)	0.5
N/A	Flare Type LT	N/A	N/A	Flare Type RT	N/A
N/A	Flare Slope LT (%)	N/A	N/A	Flare Slope RT (%)	N/A
N/A	Flare Traversable LT?	N/A	N/A	Flare Traversable RT?	N/A
N/A	Landing Length (in)	N/A	N/A	DWS Provided?	N/A
N/A	Landing Width (in)	N/A	N/A	DWS Contrast?	N/A
N/A	Landing Slope (%)	N/A	N/A	DWS Length (in)	N/A
N/A	Landing X Slope (%)	N/A	N/A	DWS Full Width?	N/A
N/A	Landing Curb? (Y/N)	N/A	N/A	DWS Offset (in)	N/A
N/A	Shared Landing?	N/A			
N/A	Gutter Ponding?	N/A	N/A	Gutter Slope (%)	N/A
N/A	Gutter Lip Ht (in)	N/A	N/A	Gutter X Slope (%)	N/A
N/A	Painted X Walk1?	No	N/A	Painted X Walk2?	N/A
	X Walk 1 Direction	To N		X Walk 2 Direction	N/A
N/A	X Walk 1 Width (in)	N/A	N/A	X Walk 2 Width (in)	N/A
	X Walk 1 Slope (%)	0.7		X Walk 2 Slope (%)	N/A
	X Walk 1 X Slope (%)	4.4		X Walk 2 X Slope (%)	N/A

Remove & Replace Entire Ramp.
