Access Compliance Report
Public Rights-of-Way
(Curb Ramps)

Intersection ID: 27503 | **Main Street:** ALTON_FARM_LN | **Cross Street:** BLUE_CEDAR_LN | **Location:** SW

ADA ID: 5AF77273B457 | **Ramp Type:** PerpDiag | **Initial Pass/Fail:** Fail | **Overall Compliance:** No | **Severity Score:** 22.5

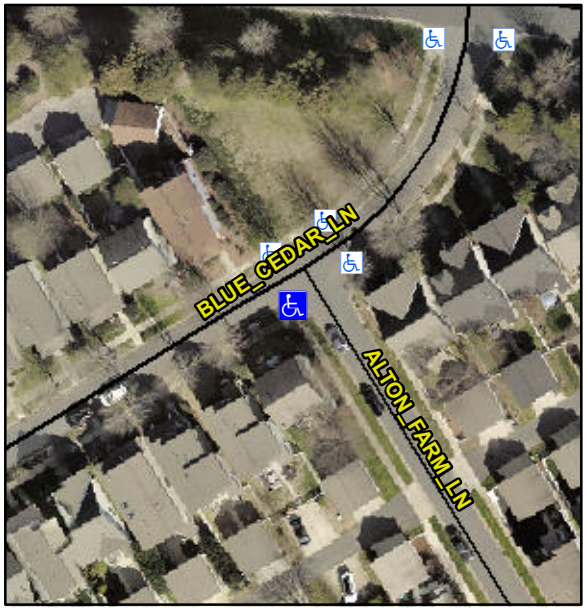
Not Found, R304.5.1, R304.2.2, R304.5.3

Compliance	Description	Data	Compliance	Description	Data
N/A	Ramp Length (in)	65.0	No	Ramp Slope (%)	10.6
No	Ramp Width (in)	46.0	No	Ramp XSlope (%)	4.0
N/A	Flare Type LT	N/A	N/A	Flare Type RT	N/A
N/A	Flare Slope LT (%)	N/A	N/A	Flare Slope RT (%)	N/A
N/A	Flare Traversable LT?	N/A	N/A	Flare Traversable RT?	N/A
N/A	Landing Length (in)	N/A	N/A	DWS Provided?	N/A
N/A	Landing Width (in)	N/A	N/A	DWS Contrast?	N/A
N/A	Landing Slope (%)	N/A	N/A	DWS Length (in)	N/A
N/A	Landing X Slope (%)	N/A	N/A	DWS Full Width?	N/A
N/A	Landing Curb? (Y/N)	N/A	N/A	DWS Offset (in)	N/A
N/A	Shared Landing?	N/A			
N/A	Gutter Ponding?	N/A	N/A	Gutter Slope (%)	N/A
N/A	Gutter Lip Ht (in)	N/A	N/A	Gutter X Slope (%)	N/A
N/A	Painted X Walk1?	No	N/A	Painted X Walk2?	No
	X Walk 1 Direction	To NE		X Walk 2 Direction	To N
N/A	X Walk 1 Width (in)	N/A	N/A	X Walk 2 Width (in)	N/A
	X Walk 1 Slope (%)	5.4		X Walk 2 Slope (%)	1.4
	X Walk 1 X Slope (%)	0.1		X Walk 2 X Slope (%)	1.6

Remove & Replace Curb Ramp With Two New Directional Ramps or Equivalent.
