Access Compliance Report

## Public Rights-of-Way
(Curb Ramps)

Intersection ID: 4194	Main Street: COLVARD_PARK_WY	Cross Street: MALLARD_CREEK_RD	Location: NW
ADA ID: 5AFE63E8306C	Ramp Type: Perp	Initial Pass/Fail: Fail	Overall Compliance: No	Severity Score: 25

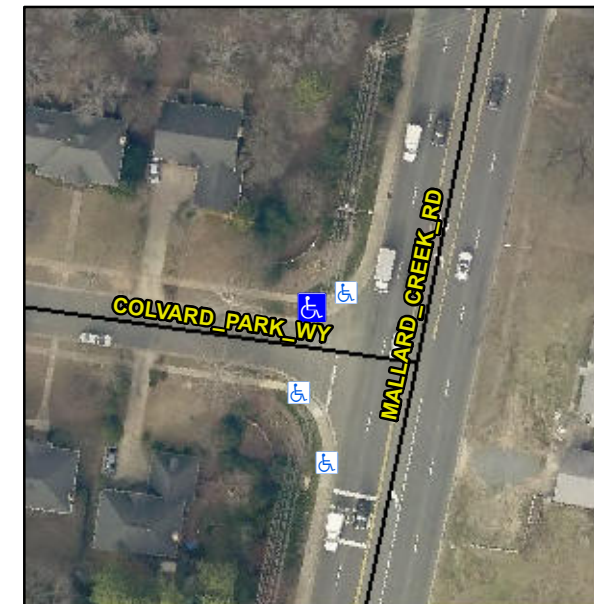
R304.2.2

Compliance	Description	Data	Compliance	Description	Data
N/A	Ramp Length (in)	56.0	No	Ramp Slope (%)	15.1
Yes	Ramp Width (in)	48.0	Yes	Ramp XSlope (%)	1.6
N/A	Flare Type LT	N/A	N/A	Flare Type RT	N/A
N/A	Flare Slope LT (%)	N/A	N/A	Flare Slope RT (%)	N/A
N/A	Flare Traversable LT?	N/A	N/A	Flare Traversable RT?	N/A
N/A	Landing Length (in)	N/A	N/A	DWS Provided?	N/A
N/A	Landing Width (in)	N/A	N/A	DWS Contrast?	N/A
N/A	Landing Slope (%)	N/A	N/A	DWS Length (in)	N/A
N/A	Landing X Slope (%)	N/A	N/A	DWS Full Width?	N/A
N/A	Landing Curb? (Y/N)	N/A	N/A	DWS Offset (in)	N/A
N/A	Shared Landing?	N/A			
N/A	Gutter Ponding?	N/A	N/A	Gutter Slope (%)	N/A
N/A	Gutter Lip Ht (in)	N/A	N/A	Gutter X Slope (%)	N/A
N/A	Painted X Walk1?	No	N/A	Painted X Walk2?	N/A
	X Walk 1 Direction	To S		X Walk 2 Direction	N/A
N/A	X Walk 1 Width (in)	N/A	N/A	X Walk 2 Width (in)	N/A
	X Walk 1 Slope (%)	0.6		X Walk 2 Slope (%)	N/A
	X Walk 1 X Slope (%)	3.3		X Walk 2 X Slope (%)	N/A

Remove & Replace Entire Ramp.
