Access Compliance Report
Public Rights-of-Way
(Curb Ramps)

Intersection ID: 48713	Main Street: ROLLING_CREEK_CT	Cross Street: KILCULLEN_DR	Location:	E
ADA ID: 5B1DD4443BD7	Ramp Type: PerpDiag	Initial Pass/Fail: Fail	Overall Compliance: No	Severity Score: 22.5

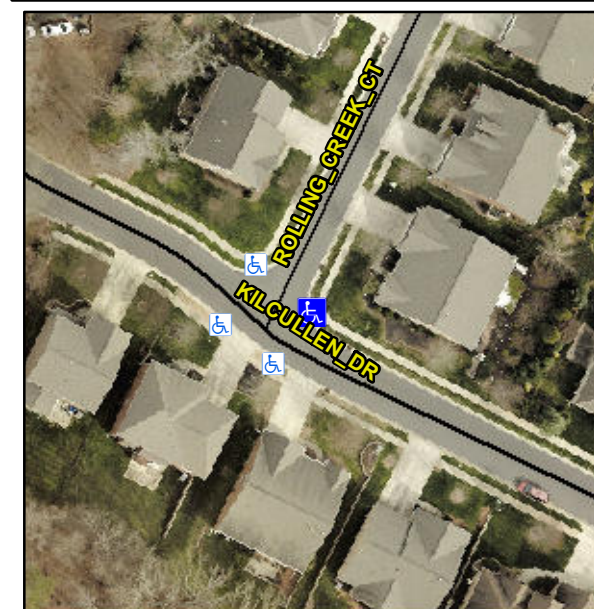
R304.5.1, R304.2.2, R304.5.3

Compliance	Description	Data	Compliance	Description	Data
N/A	Ramp Length (in)	52.0	No	Ramp Slope (%)	10.0
No	Ramp Width (in)	46.0	No	Ramp XSlope (%)	3.3
N/A	Flare Type LT	N/A	N/A	Flare Type RT	N/A
N/A	Flare Slope LT (%)	N/A	N/A	Flare Slope RT (%)	N/A
N/A	Flare Traversable LT?	N/A	N/A	Flare Traversable RT?	N/A
N/A	Landing Length (in)	N/A	N/A	DWS Provided?	N/A
N/A	Landing Width (in)	N/A	N/A	DWS Contrast?	N/A
N/A	Landing Slope (%)	N/A	N/A	DWS Length (in)	N/A
N/A	Landing X Slope (%)	N/A	N/A	DWS Full Width?	N/A
N/A	Landing Curb? (Y/N)	N/A	N/A	DWS Offset (in)	N/A
N/A	Shared Landing?	N/A			
N/A	Gutter Ponding?	N/A	N/A	Gutter Slope (%)	N/A
N/A	Gutter Lip Ht (in)	N/A	N/A	Gutter X Slope (%)	N/A
N/A	Painted X Walk1?	No	N/A	Painted X Walk2?	No
	X Walk 1 Direction	To NW		X Walk 2 Direction	To SW
N/A	X Walk 1 Width (in)	N/A	N/A	X Walk 2 Width (in)	N/A
	X Walk 1 Slope (%)	2.5		X Walk 2 Slope (%)	0.9
	X Walk 1 X Slope (%)	0.7		X Walk 2 X Slope (%)	2.5

Remove & Replace Curb Ramp With Two New Directional Ramps or Equivalent.
