Access Compliance Report
Public Rights-of-Way
(Curb Ramps)

Intersection ID: 27660	Main Street: CATHERINE'S_MINE_CR	Cross Street: NOLEN_LN	Location:	NE
ADA ID: 5B475545E0FD	Ramp Type: Perp	Initial Pass/Fail: Fail	Overall Compliance: No	Severity Score: 13.75

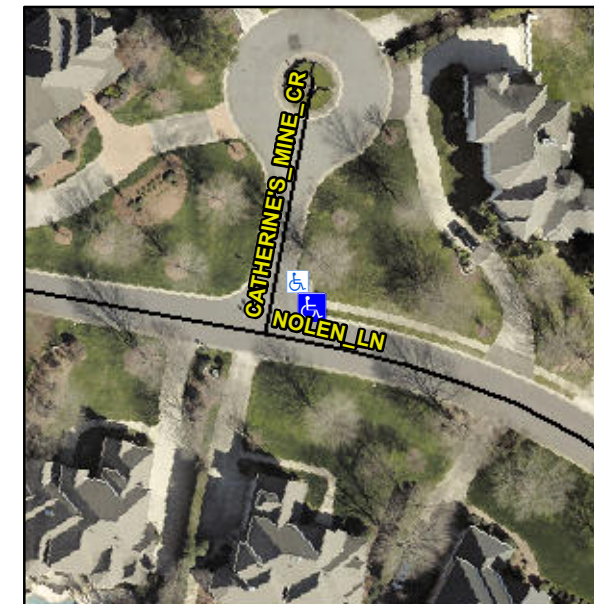
Not Found, R304.2.2, R304.5.3

Compliance	Description	Data	Compliance	Description	Data
N/A	Ramp Length (in)	87.0	No	Ramp Slope (%)	9.4
Yes	Ramp Width (in)	180.0	No	Ramp XSlope (%)	4.8
N/A	Flare Type LT	N/A	N/A	Flare Type RT	N/A
N/A	Flare Slope LT (%)	N/A	N/A	Flare Slope RT (%)	N/A
N/A	Flare Traversable LT?	N/A	N/A	Flare Traversable RT?	N/A
N/A	Landing Length (in)	N/A	N/A	DWS Provided?	N/A
N/A	Landing Width (in)	N/A	N/A	DWS Contrast?	N/A
N/A	Landing Slope (%)	N/A	N/A	DWS Length (in)	N/A
N/A	Landing X Slope (%)	N/A	N/A	DWS Full Width?	N/A
N/A	Landing Curb? (Y/N)	N/A	N/A	DWS Offset (in)	N/A
N/A	Shared Landing?	N/A			
N/A	Gutter Ponding?	N/A	N/A	Gutter Slope (%)	N/A
N/A	Gutter Lip Ht (in)	N/A	N/A	Gutter X Slope (%)	N/A
N/A	Painted X Walk1?	No	N/A	Painted X Walk2?	N/A
	X Walk 1 Direction	To SW		X Walk 2 Direction	N/A
N/A	X Walk 1 Width (in)	N/A	N/A	X Walk 2 Width (in)	N/A
	X Walk 1 Slope (%)	3.5		X Walk 2 Slope (%)	N/A
	X Walk 1 X Slope (%)	2.7		X Walk 2 X Slope (%)	N/A

Remove & Replace Entire Ramp.
