Access Compliance Report
Public Rights-of-Way
(Curb Ramps)

Intersection ID: 3217	Main Street: CARVER_POND_RD	Cross Street: SPRING_PARK_DR	Location: E
ADA ID: 5B623619F65A	Ramp Type: PerpDiag	Initial Pass/Fail: Fail	Overall Compliance: No Severity Score: 47.5

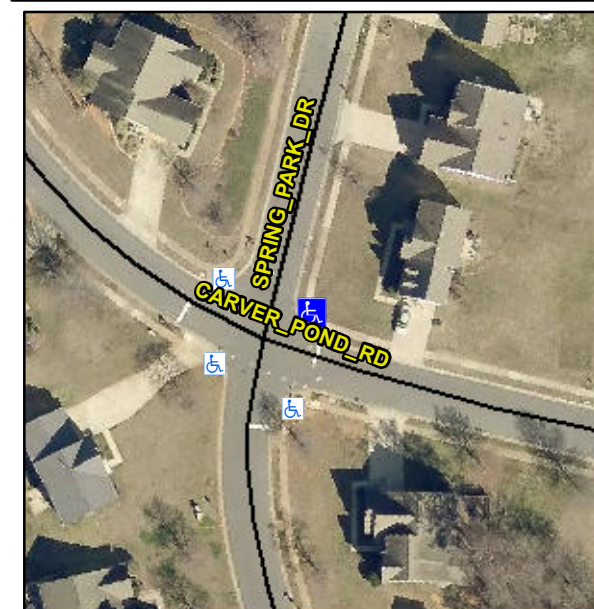
Not Found, R304.5.1, R304.5.3

Compliance	Description	Data	Compliance	Description	Data
N/A	Ramp Length (in)	94.0	Yes	Ramp Slope (%)	5.9
No	Ramp Width (in)	26.0	No	Ramp XSlope (%)	6.6
N/A	Flare Type LT	N/A	N/A	Flare Type RT	N/A
N/A	Flare Slope LT (%)	N/A	N/A	Flare Slope RT (%)	N/A
N/A	Flare Traversable LT?	N/A	N/A	Flare Traversable RT?	N/A
N/A	Landing Length (in)	N/A	N/A	DWS Provided?	N/A
N/A	Landing Width (in)	N/A	N/A	DWS Contrast?	N/A
N/A	Landing Slope (%)	N/A	N/A	DWS Length (in)	N/A
N/A	Landing X Slope (%)	N/A	N/A	DWS Full Width?	N/A
N/A	Landing Curb? (Y/N)	N/A	N/A	DWS Offset (in)	N/A
N/A	Shared Landing?	N/A			
N/A	Gutter Ponding?	N/A	N/A	Gutter Slope (%)	N/A
N/A	Gutter Lip Ht (in)	N/A	N/A	Gutter X Slope (%)	N/A
N/A	Painted X Walk1?	No	N/A	Painted X Walk2?	No
	X Walk 1 Direction	To NW		X Walk 2 Direction	To SW
N/A	X Walk 1 Width (in)	N/A	N/A	X Walk 2 Width (in)	N/A
	X Walk 1 Slope (%)	7.3		X Walk 2 Slope (%)	1.4
	X Walk 1 X Slope (%)	0.7		X Walk 2 X Slope (%)	6.5

N/A	Ramp inside XWalk1?	N/A	N/A	Ramp inside XWalk2?	N/A
	Road Slope (%)	5.5	N/A	Clear Space?	N/A
	Road X Slope (%)	8.2	N/A	Clear Space to XWalk (in)	N/A
N/A	Any Obstructions?	N/A	N/A	Storm Grate/Utility Hazard?	N/A
	Obstruction Type			Storm Grate/Utility Type	
N/A					N/A
			Yes	Surface Condition? (G/P)	Good

Remove & Replace Curb Ramp With Two New Directional Ramps or Equivalent.
