# Access Compliance Report
Public Rights-of-Way
(Curb Ramps)

Intersection ID: 28662	Main Street: MEADOWMONT_DR	Cross Street: MEADOWMONT_VIEW_DR	Location:	N
ADA ID: 5C4F62BC5676	Ramp Type: BlendTrans1	Initial Pass/Fail: Fail	Overall Compliance: No	Severity Score: 8.75

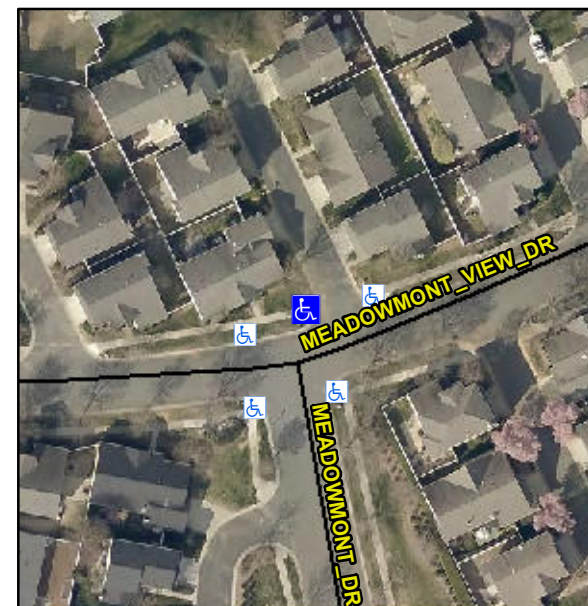
Not Found, R304.5.1

Compliance	Description	Data	Compliance	Description	Data
N/A	Ramp Length (in)	47.0	Yes	BlendTrans Slope (%)	2.2
No	Ramp Width (in)	46.5	Yes	BlendTrans XSlope (%)	1.4
N/A	Flare Type LT	N/A	N/A	Flare Type RT	N/A
N/A	Flare Slope LT (%)	N/A	N/A	Flare Slope RT (%)	N/A
N/A	Flare Traversable LT?	N/A	N/A	Flare Traversable RT?	N/A
N/A	Landing Length (in)	N/A	N/A	DWS Provided?	N/A
N/A	Landing Width (in)	N/A	N/A	DWS Contrast?	N/A
N/A	Landing Slope (%)	N/A	N/A	DWS Length (in)	N/A
N/A	Landing X Slope (%)	N/A	N/A	DWS Full Width?	N/A
N/A	Landing Curb? (Y/N)	N/A	N/A	DWS Offset (in)	N/A
N/A	Shared Landing?	N/A			
N/A	Gutter Ponding?	N/A	N/A	Gutter Slope (%)	N/A
N/A	Gutter Lip Ht (in)	N/A	N/A	Gutter X Slope (%)	N/A
N/A	Painted X Walk1?	No	N/A	Painted X Walk2?	No
	X Walk 1 Direction	To S		X Walk 2 Direction	To E
	X Walk 1 Width (in)	N/A		X Walk 2 Width (in)	N/A
	X Walk 1 Slope (%)	1.4		X Walk 2 Slope (%)	3.1
	X Walk 1 X Slope (%)	0.4		X Walk 2 X Slope (%)	0.3

N/A	Ramp inside XWalk1?	N/A	N/A	Ramp inside XWalk2?	N/A
	Road Slope (%)	1.2		Clear Space?	N/A
	Road X Slope (%)	0.1	N/A	Clear Space to XWalk (in)	N/A
N/A	Any Obstructions?	N/A	N/A	Storm Grate/Utility Hazard?	N/A
	Obstruction Type			Storm Grate/Utility Type	
N/A					N/A
			Yes	Surface Condition? (G/P)	Good
			No	Curb Slope (%)	8.9

Remove & Replace Curb Ramp With Two New Directional Ramps or Equivalent.
