Access Compliance Report
Public Rights-of-Way
(Curb Ramps)

Intersection ID: 8795	Main Street: BANCROFT_ST	Cross Street: DOGWOOD_AV	Location:	SE
ADA ID: 5C7137F96B78	Ramp Type: Perp	Initial Pass/Fail: Pass	Overall Compliance: No	Severity Score: 12.5

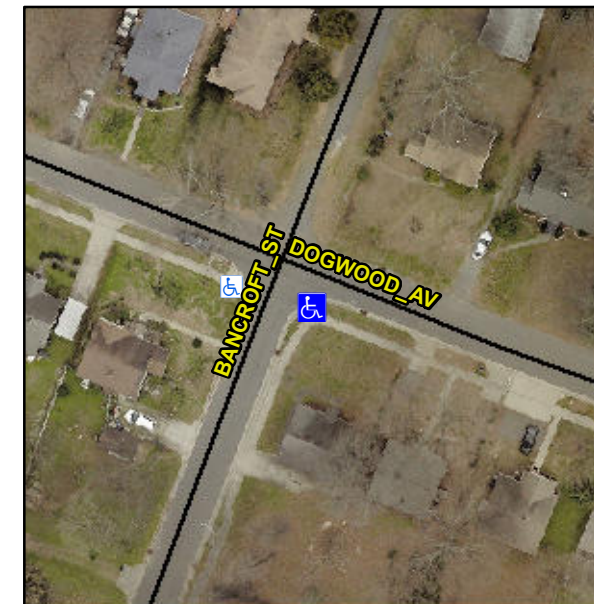
Not Found, R305.2, R302.7.2, R304.5.4, R304.5.3

Compliance	Description	Data	Compliance	Description	Data
N/A	Ramp Length (in)	61.0	Yes	Ramp Slope (%)	8.0
Yes	Ramp Width (in)	49.0	Yes	Ramp XSlope (%)	1.7
N/A	Flare Type LT	Sloped	N/A	Flare Type RT	N/A
N/A	Flare Slope LT (%)	10.5	N/A	Flare Slope RT (%)	3.5
N/A	Flare Traversable LT?	No	N/A	Flare Traversable RT?	No
Yes	Landing Length (in)	59.5	Yes	DWS Provided?	Yes
Yes	Landing Width (in)	48.0	Yes	DWS Contrast?	Yes
Yes	Landing Slope (%)	1.4	Yes	DWS Length (in)	24.0
Yes	Landing X Slope (%)	1.7	Yes	DWS Full Width?	Yes
N/A	Landing Curb? (Y/N)	No	No	DWS Offset (in)	5.0
N/A	Shared Landing?	No			
Yes	Gutter Ponding?	No	No	Gutter Slope (%)	6.0
No	Gutter Lip Ht (in)	0.5	No	Gutter X Slope (%)	2.1
N/A	Painted X Walk1?	No	N/A	Painted X Walk2?	N/A
	X Walk 1 Direction	To NW		X Walk 2 Direction	N/A
N/A	X Walk 1 Width (in)	N/A	N/A	X Walk 2 Width (in)	N/A
	X Walk 1 Slope (%)	2.9		X Walk 2 Slope (%)	N/A
	X Walk 1 X Slope (%)	0.6		X Walk 2 X Slope (%)	N/A

N/A	Ramp inside XWalk1?	N/A	N/A	Ramp inside XWalk2?	N/A
	Road Slope (%)	N/A	N/A	Clear Space?	Yes
	Road X Slope (%)	N/A	N/A	Clear Space to XWalk (in)	N/A
Yes	Any Obstructions?	No	Yes	Storm Grate/Utility Hazard?	No
	Obstruction Type			Storm Grate/Utility Type	
N/A					N/A
			Yes	Surface Condition? (G/P)	Good

Remove & Replace Entire Ramp.
Remove & Replace Gutter.
