Access Compliance Report
Public Rights-of-Way
(Curb Ramps)

Intersection ID: 50544	Main Street: ALCEA_ST	Cross Street: CAYENNE_DR	Location:	E
ADA ID: 5DD071DA9A4A	Ramp Type: Perpendicular Diagonal	Initial Pass/Fail: Fail	Overall Compliance: No	Severity Score: 13.75

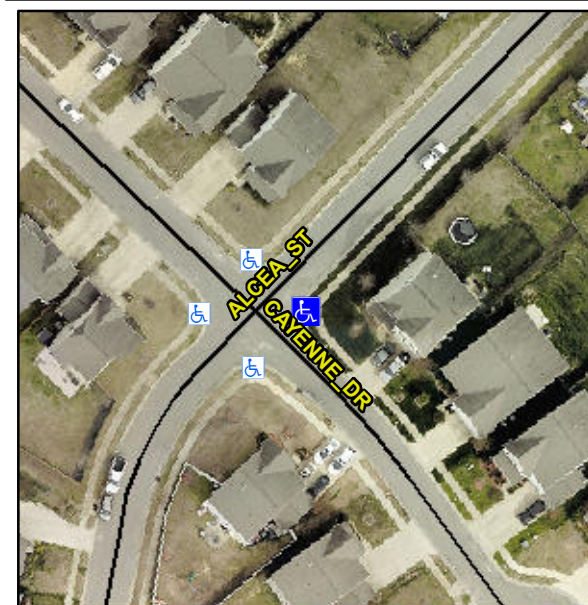
Not Found, R304.2.2, R304.5.3

Compliance	Description	Data	Compliance	Description	Data
N/A	Ramp Length (in)	48.0	No	Ramp Slope (%)	8.8
Yes	Ramp Width (in)	48.0	No	Ramp XSlope (%)	2.4
N/A	Flare Type LT	N/A	N/A	Flare Type RT	N/A
N/A	Flare Slope LT (%)	N/A	N/A	Flare Slope RT (%)	N/A
N/A	Flare Traversable LT?	N/A	N/A	Flare Traversable RT?	N/A
N/A	Landing Length (in)	N/A	N/A	DWS Provided?	N/A
N/A	Landing Width (in)	N/A	N/A	DWS Contrast?	N/A
N/A	Landing Slope (%)	N/A	N/A	DWS Length (in)	N/A
N/A	Landing X Slope (%)	N/A	N/A	DWS Full Width?	N/A
N/A	Landing Curb? (Y/N)	N/A	N/A	DWS Offset (in)	N/A
N/A	Shared Landing?	N/A			
N/A	Gutter Ponding?	Yes	N/A	Gutter Slope (%)	N/A
N/A	Gutter Lip Ht (in)	N/A	N/A	Gutter X Slope (%)	N/A
N/A	Painted X Walk1?	No	N/A	Painted X Walk2?	No
	X Walk 1 Direction	To NW		X Walk 2 Direction	To SW
N/A	X Walk 1 Width (in)	N/A	N/A	X Walk 2 Width (in)	N/A
	X Walk 1 Slope (%)	0.2		X Walk 2 Slope (%)	0.2
	X Walk 1 X Slope (%)	0.9		X Walk 2 X Slope (%)	1.5

Remove & Replace Curb Ramp With Two New Directional Ramps or Equivalent.
