Access Compliance Report
Public Rights-of-Way
(Curb Ramps)

Intersection ID: N/A	Main Street: PROVIDENCE_RD	Cross Street: N/A	Location:	SE
ADA ID: 5F6C94513308	Ramp Type: PerpDiag	Initial Pass/Fail: Fail	Overall Compliance: No	Severity Score: 21.25

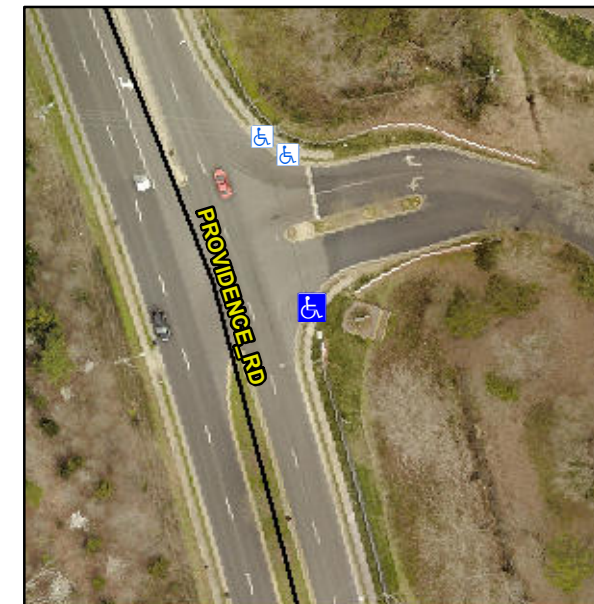
Not Found, R304.5.1, R304.5.3

Compliance	Description	Data	Compliance	Description	Data
N/A	Ramp Length (in)	69.0	Yes	Ramp Slope (%)	7.4
No	Ramp Width (in)	41.0	No	Ramp XSlope (%)	6.7
N/A	Flare Type LT	N/A	N/A	Flare Type RT	N/A
N/A	Flare Slope LT (%)	N/A	N/A	Flare Slope RT (%)	N/A
N/A	Flare Traversable LT?	N/A	N/A	Flare Traversable RT?	N/A
N/A	Landing Length (in)	N/A	N/A	DWS Provided?	N/A
N/A	Landing Width (in)	N/A	N/A	DWS Contrast?	N/A
N/A	Landing Slope (%)	N/A	N/A	DWS Length (in)	N/A
N/A	Landing X Slope (%)	N/A	N/A	DWS Full Width?	N/A
N/A	Landing Curb? (Y/N)	N/A	N/A	DWS Offset (in)	N/A
N/A	Shared Landing?	N/A			
N/A	Gutter Ponding?	N/A	N/A	Gutter Slope (%)	N/A
N/A	Gutter Lip Ht (in)	N/A	N/A	Gutter X Slope (%)	N/A
N/A	Painted X Walk1?	No	N/A	Painted X Walk2?	No
	X Walk 1 Direction	To N		X Walk 2 Direction	To W
N/A	X Walk 1 Width (in)	N/A	N/A	X Walk 2 Width (in)	N/A
	X Walk 1 Slope (%)	2.8		X Walk 2 Slope (%)	3.5
	X Walk 1 X Slope (%)	7.2		X Walk 2 X Slope (%)	1.9

Remove & Replace Curb Ramp With Two New Directional Ramps or Equivalent.
