Access Compliance Report
Public Rights-of-Way
(Curb Ramps)

Intersection ID: 3569	**Main Street: OLYMPUS_DR**	**Cross Street: SHIMMERING_LAKE_DR**	**Location: NW**
ADA ID: 600D3A023CDC	**Ramp Type: Perp**	**Initial Pass/Fail: Fail** **Overall Compliance: No**	**Severity Score: 22.5**

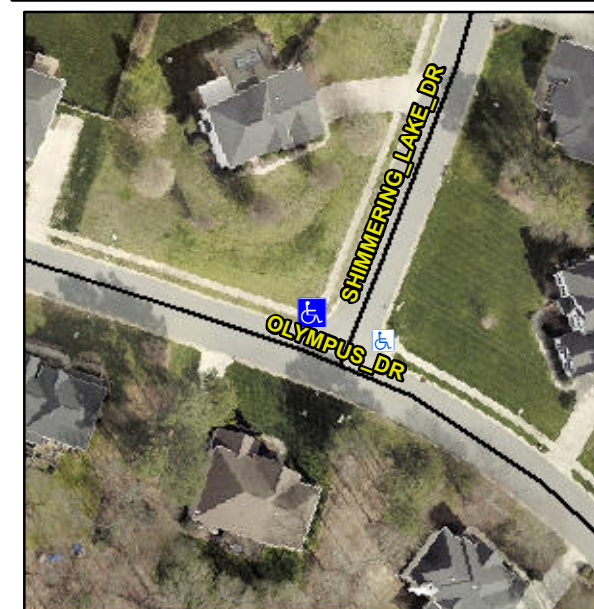
R304.5.1, R304.2.2, R304.5.3

Compliance	Description	Data	Compliance	Description	Data
N/A	Ramp Length (in)	44.0	No	Ramp Slope (%)	10.0
No	Ramp Width (in)	36.0	No	Ramp XSlope (%)	3.5
N/A	Flare Type LT	N/A	N/A	Flare Type RT	N/A
N/A	Flare Slope LT (%)	N/A	N/A	Flare Slope RT (%)	N/A
N/A	Flare Traversable LT?	N/A	N/A	Flare Traversable RT?	N/A
N/A	Landing Length (in)	N/A	N/A	DWS Provided?	N/A
N/A	Landing Width (in)	N/A	N/A	DWS Contrast?	N/A
N/A	Landing Slope (%)	N/A	N/A	DWS Length (in)	N/A
N/A	Landing X Slope (%)	N/A	N/A	DWS Full Width?	N/A
N/A	Landing Curb? (Y/N)	N/A	N/A	DWS Offset (in)	N/A
N/A	Shared Landing?	N/A			
N/A	Gutter Ponding?	N/A	N/A	Gutter Slope (%)	N/A
N/A	Gutter Lip Ht (in)	N/A	N/A	Gutter X Slope (%)	N/A
N/A	Painted X Walk1?	No	N/A	Painted X Walk2?	N/A
	X Walk 1 Direction	To SE		X Walk 2 Direction	N/A
N/A	X Walk 1 Width (in)	N/A	N/A	X Walk 2 Width (in)	N/A
	X Walk 1 Slope (%)	1.8		X Walk 2 Slope (%)	N/A
	X Walk 1 X Slope (%)	3.7		X Walk 2 X Slope (%)	N/A

Remove & Replace Entire Ramp.
