# Access Compliance Report
# Public Rights-of-Way
# (Curb Ramps)

| Intersection ID: 50582 | Main Street: DOWNY_BIRCH_RD | Cross Street: PAPER_TREE_RD | Location: SW |
| ADA ID: 601468ABC095 | Ramp Type: Perp | Initial Pass/Fail: Fail | Overall Compliance: No Severity Score: 22.5 |

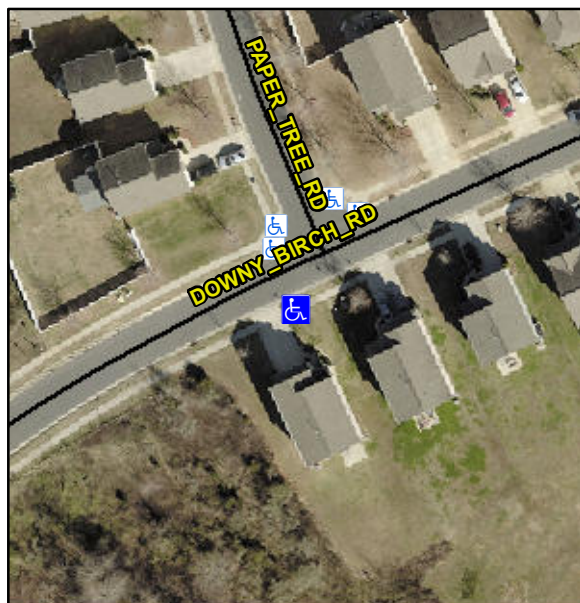
**Not Found, R304.5.1, R304.2.2**

| Compliance | Description | Data | Compliance | Description | Data |
|---|---|---|---|---|---|
| N/A | Ramp Length (in) | 47.0 | No | Ramp Slope (%) | 9.3 |
| No | Ramp Width (in) | 47.5 | Yes | Ramp XSlope (%) | 2.9 |

**Remove & Replace Entire Ramp.**
