Access Compliance Report
Public Rights-of-Way
(Curb Ramps)

Intersection ID: 15581 **Main Street:** CLANTON_RD **Cross Street:** ST_VARDELL_LN **Location:** NE

ADA ID: 60D4F83593D6 **Ramp Type:** PerpDiag **Initial Pass/Fail:** Fail **Overall Compliance:** No **Severity Score:** 12.5

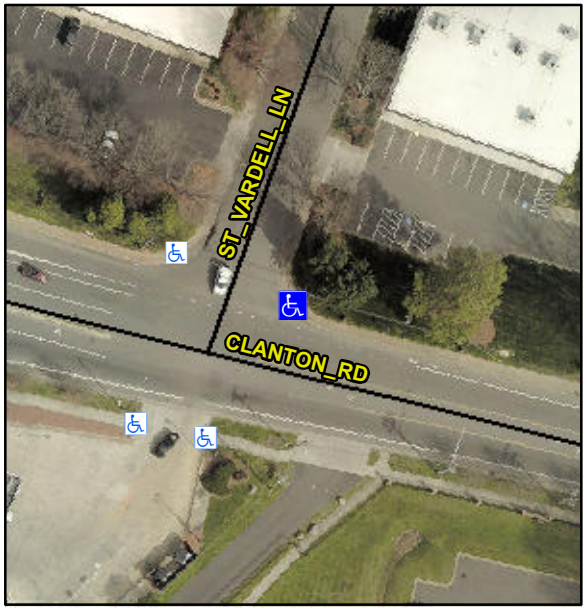
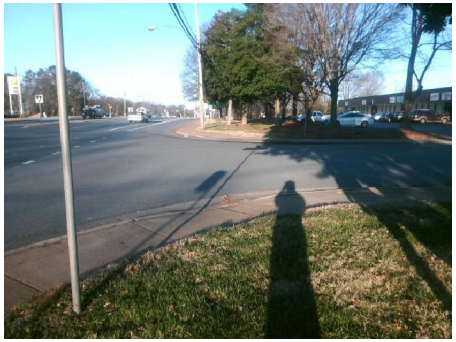
R304.2.2

Compliance	Description	Data	Compliance	Description	Data
N/A	Ramp Length (in)	61.0	No	Ramp Slope (%)	10.1
Yes	Ramp Width (in)	48.0	Yes	Ramp XSlope (%)	0.2
N/A	Flare Type LT	N/A	N/A	Flare Type RT	N/A
N/A	Flare Slope LT (%)	N/A	N/A	Flare Slope RT (%)	N/A
N/A	Flare Traversable LT?	N/A	N/A	Flare Traversable RT?	N/A
N/A	Landing Length (in)	N/A	N/A	DWS Provided?	N/A
N/A	Landing Width (in)	N/A	N/A	DWS Contrast?	N/A
N/A	Landing Slope (%)	N/A	N/A	DWS Length (in)	N/A
N/A	Landing X Slope (%)	N/A	N/A	DWS Full Width?	N/A
N/A	Landing Curb? (Y/N)	N/A	N/A	DWS Offset (in)	N/A
N/A	Shared Landing?	N/A			
N/A	Gutter Ponding?	N/A	N/A	Gutter Slope (%)	N/A
N/A	Gutter Lip Ht (in)	N/A	N/A	Gutter X Slope (%)	N/A
N/A	Painted X Walk1?	No	N/A	Painted X Walk2?	No
	X Walk 1 Direction	To NW		X Walk 2 Direction	To SW
N/A	X Walk 1 Width (in)	N/A	N/A	X Walk 2 Width (in)	N/A
	X Walk 1 Slope (%)	3.5		X Walk 2 Slope (%)	1.2

Remove & Replace Curb Ramp With Two New Directional Ramps or Equivalent.
