Access Compliance Report
Public Rights-of-Way
(Curb Ramps)

Intersection ID: 48769	**Main Street:** KNOTHOLE_LN	**Cross Street:** SONOMA_VALLEY_DR	**Location:** NE
ADA ID: 61F5C2ECFD2D	**Ramp Type:** PerpDiag	**Initial Pass/Fail:** Fail **Overall Compliance:** No	**Severity Score:** 8.75

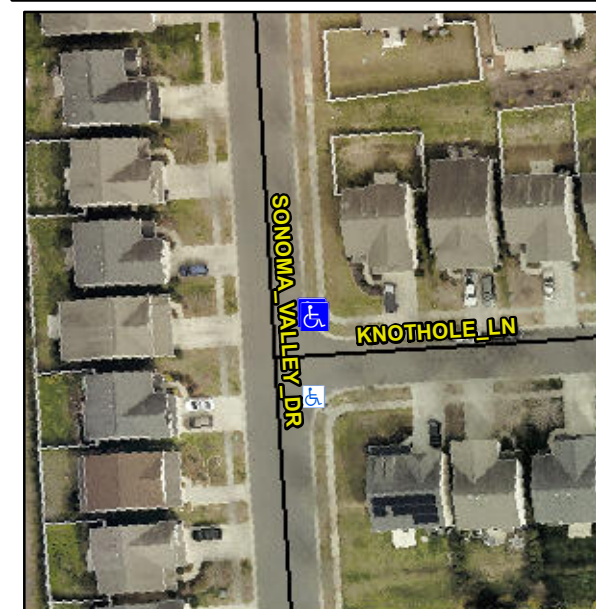
Not Found, R304.5.1

Compliance	Description	Data	Compliance	Description	Data
N/A	Ramp Length (in)	69.0	Yes	Ramp Slope (%)	6.0
No	Ramp Width (in)	47.5	Yes	Ramp XSlope (%)	0.2
N/A	Flare Type LT	N/A	N/A	Flare Type RT	N/A
N/A	Flare Slope LT (%)	N/A	N/A	Flare Slope RT (%)	N/A
N/A	Flare Traversable LT?	N/A	N/A	Flare Traversable RT?	N/A
N/A	Landing Length (in)	N/A	N/A	DWS Provided?	N/A
N/A	Landing Width (in)	N/A	N/A	DWS Contrast?	N/A
N/A	Landing Slope (%)	N/A	N/A	DWS Length (in)	N/A
N/A	Landing X Slope (%)	N/A	N/A	DWS Full Width?	N/A
N/A	Landing Curb? (Y/N)	N/A	N/A	DWS Offset (in)	N/A
N/A	Shared Landing?	N/A			
N/A	Gutter Ponding?	N/A	N/A	Gutter Slope (%)	N/A
N/A	Gutter Lip Ht (in)	N/A	N/A	Gutter X Slope (%)	N/A
N/A	Painted X Walk1?	No	N/A	Painted X Walk2?	No
	X Walk 1 Direction	To W		X Walk 2 Direction	To S
N/A	X Walk 1 Width (in)	N/A	N/A	X Walk 2 Width (in)	N/A
	X Walk 1 Slope (%)	1.8		X Walk 2 Slope (%)	2.2
	X Walk 1 X Slope (%)	1.1		X Walk 2 X Slope (%)	2.9

Remove & Replace Curb Ramp With Two New Directional Ramps or Equivalent.
