Access Compliance Report
Public Rights-of-Way
(Curb Ramps)

Intersection ID: 10029120	Main Street: JAMES_BLAKENEY_AV	Cross Street: N/A	Location:	NW
ADA ID: 6208D5AE182A	Ramp Type: PerpDiag	Initial Pass/Fail: Fail	Overall Compliance: No	Severity Score: 13.75

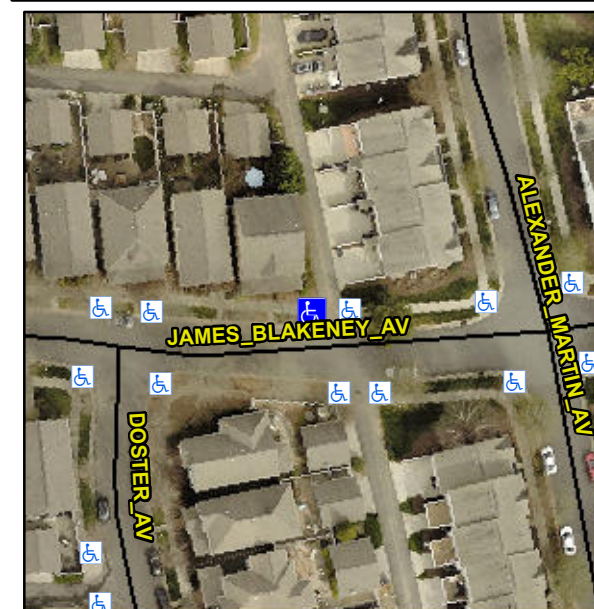
R304.2.2, R304.5.3

Compliance	Description	Data	Compliance	Description	Data
N/A	Ramp Length (in)	82.0	No	Ramp Slope (%)	9.0
Yes	Ramp Width (in)	49.0	No	Ramp XSlope (%)	2.3
N/A	Flare Type LT	N/A	N/A	Flare Type RT	N/A
N/A	Flare Slope LT (%)	N/A	N/A	Flare Slope RT (%)	N/A
N/A	Flare Traversable LT?	N/A	N/A	Flare Traversable RT?	N/A
N/A	Landing Length (in)	N/A	N/A	DWS Provided?	N/A
N/A	Landing Width (in)	N/A	N/A	DWS Contrast?	N/A
N/A	Landing Slope (%)	N/A	N/A	DWS Length (in)	N/A
N/A	Landing X Slope (%)	N/A	N/A	DWS Full Width?	N/A
N/A	Landing Curb? (Y/N)	N/A	N/A	DWS Offset (in)	N/A
N/A	Shared Landing?	N/A			
N/A	Gutter Ponding?	N/A	N/A	Gutter Slope (%)	N/A
N/A	Gutter Lip Ht (in)	N/A	N/A	Gutter X Slope (%)	N/A
N/A	Painted X Walk1?	No	N/A	Painted X Walk2?	No
	X Walk 1 Direction	To S		X Walk 2 Direction	To SE
N/A	X Walk 1 Width (in)	N/A	N/A	X Walk 2 Width (in)	N/A
	X Walk 1 Slope (%)	4.7		X Walk 2 Slope (%)	3.2
	X Walk 1 X Slope (%)	0.9		X Walk 2 X Slope (%)	0.9

Remove & Replace Curb Ramp With Two New Directional Ramps or Equivalent.
