Access Compliance Report
Public Rights-of-Way
(Curb Ramps)

Intersection ID: 9623	Main Street: BREWTON_DR	Cross Street: PEACEFUL_WAY_DR	Location:	SE
ADA ID: 626CDF92A3FC	Ramp Type: PerpDiag	Initial Pass/Fail: Fail	Overall Compliance: No	Severity Score: 17.5

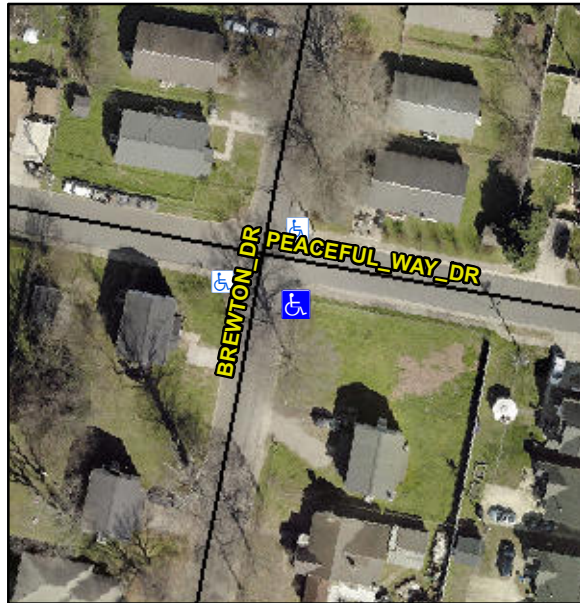
Not Found, R304.5.1

Compliance	Description	Data	Compliance	Description	Data
N/A	Ramp Length (in)	47.0	Yes	Ramp Slope (%)	5.8
No	Ramp Width (in)	35.5	Yes	Ramp XSlope (%)	1.4
N/A	Flare Type LT	N/A	N/A	Flare Type RT	N/A
N/A	Flare Slope LT (%)	N/A	N/A	Flare Slope RT (%)	N/A
N/A	Flare Traversable LT?	N/A	N/A	Flare Traversable RT?	N/A
N/A	Landing Length (in)	N/A	N/A	DWS Provided?	N/A
N/A	Landing Width (in)	N/A	N/A	DWS Contrast?	N/A
N/A	Landing Slope (%)	N/A	N/A	DWS Length (in)	N/A
N/A	Landing X Slope (%)	N/A	N/A	DWS Full Width?	N/A
N/A	Landing Curb? (Y/N)	N/A	N/A	DWS Offset (in)	N/A
N/A	Shared Landing?	N/A			
N/A	Gutter Ponding?	N/A	N/A	Gutter Slope (%)	N/A
N/A	Gutter Lip Ht (in)	N/A	N/A	Gutter X Slope (%)	N/A
N/A	Painted X Walk1?	No	N/A	Painted X Walk2?	No
	X Walk 1 Direction	To N		X Walk 2 Direction	To W
N/A	X Walk 1 Width (in)	N/A	N/A	X Walk 2 Width (in)	N/A
	X Walk 1 Slope (%)	4.2		X Walk 2 Slope (%)	5.3
	X Walk 1 X Slope (%)	1.6		X Walk 2 X Slope (%)	2.9

Remove & Replace Curb Ramp With Two New Directional Ramps or Equivalent.
