# Access Compliance Report
Public Rights-of-Way
(Curb Ramps)

Intersection ID: 50614	Main Street: PADDLE_OAK_RD	Cross Street: BALSAM_BAY_RD	Location:	SW
ADA ID: 629B78FF739D	Ramp Type: Perp	Initial Pass/Fail: Fail	Overall Compliance: No	Severity Score: 21.25

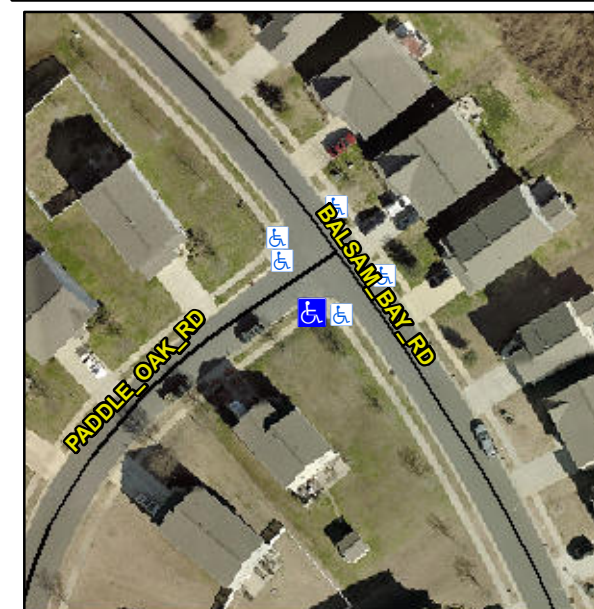
R304.5.1, R304.2.2

Compliance	Description	Data	Compliance	Description	Data
N/A	Ramp Length (in)	48.0	No	Ramp Slope (%)	9.9
No	Ramp Width (in)	47.5	Yes	Ramp XSlope (%)	0.3
N/A	Flare Type LT	N/A	N/A	Flare Type RT	N/A
N/A	Flare Slope LT (%)	N/A	N/A	Flare Slope RT (%)	N/A
N/A	Flare Traversable LT?	N/A	N/A	Flare Traversable RT?	N/A
N/A	Landing Length (in)	N/A	N/A	DWS Provided?	N/A
N/A	Landing Width (in)	N/A	N/A	DWS Contrast?	N/A
N/A	Landing Slope (%)	N/A	N/A	DWS Length (in)	N/A
N/A	Landing X Slope (%)	N/A	N/A	DWS Full Width?	N/A
N/A	Landing Curb? (Y/N)	N/A	N/A	DWS Offset (in)	N/A
N/A	Shared Landing?	N/A			
N/A	Gutter Ponding?	N/A	N/A	Gutter Slope (%)	N/A
N/A	Gutter Lip Ht (in)	N/A	N/A	Gutter X Slope (%)	N/A
N/A	Painted X Walk1?	No	N/A	Painted X Walk2?	N/A
	X Walk 1 Direction	To N		X Walk 2 Direction	N/A
N/A	X Walk 1 Width (in)	N/A	N/A	X Walk 2 Width (in)	N/A
	X Walk 1 Slope (%)	1.4		X Walk 2 Slope (%)	N/A
	X Walk 1 X Slope (%)	0.2		X Walk 2 X Slope (%)	N/A

Remove & Replace Entire Ramp.
