Access Compliance Report
Public Rights-of-Way
(Curb Ramps)

Intersection ID: N/A	**Main Street:** E_MARTIN_LUTHER_KING_JR_BV	**Cross Street:** S_CALDWELL_ST	**Location:** NE
ADA ID: 629FF746FE9F	**Ramp Type:** Para	**Initial Pass/Fail:** Fail	**Overall Compliance:** No **Severity Score:** 26.25

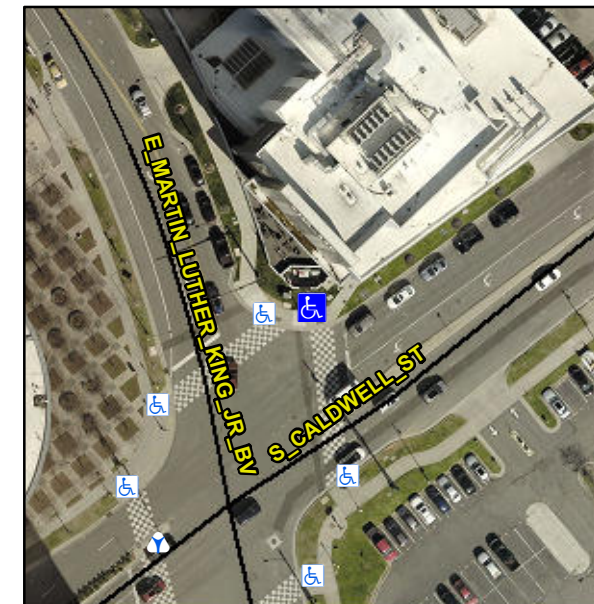
R304.3.2, R304.5.3

Compliance	Description	Data	Compliance	Description	Data
N/A	Ramp Length LT (in)	67.0	N/A	Ramp Length RT (in)	63.0
Yes	Ramp Width LT (in)	96.0	Yes	Ramp Width RT (in)	95.0
No	Ramp Slope LT (%)	12.1	Yes	Ramp Slope RT (%)	5.4
No	Ramp XSlope LT (%)	3.2	No	Ramp XSlope RT (%)	3.6
N/A	Landing Length (in)	N/A	N/A	DWS Provided?	N/A
N/A	Landing Width (in)	N/A	N/A	DWS Contrast?	N/A
N/A	Landing Slope (%)	N/A	N/A	DWS Length (in)	N/A
N/A	Landing X Slope (%)	N/A	N/A	DWS Full Width?	N/A
N/A	Landing Curb? (Y/N)	N/A	N/A	DWS Offset (in)	N/A
N/A	Shared Landing?	N/A			
N/A	Gutter Ponding?	N/A	N/A	Gutter Slope (%)	N/A
N/A	Gutter Lip Ht (in)	N/A	N/A	Gutter X Slope (%)	N/A
N/A	Painted X Walk1?	Yes	N/A	Painted X Walk2?	N/A
	X Walk 1 Direction	To S		X Walk 2 Direction	N/A
N/A	X Walk 1 Width (in)	144.0	N/A	X Walk 2 Width (in)	N/A
	X Walk 1 Slope (%)	0.2		X Walk 2 Slope (%)	N/A
	X Walk 1 X Slope (%)	2.6		X Walk 2 X Slope (%)	N/A
N/A	Ramp inside XWalk1?	Yes	N/A	Ramp inside XWalk2?	N/A

Remove & Replace Entire Ramp.
