Access Compliance Report

# Public Rights-of-Way
(Curb Ramps)

Intersection ID: 25006	Main Street: BENRIDGE_LN	Cross Street: TRUSCOTT_RD	Location:	S
ADA ID: 636BF0CCF7B8	Ramp Type: PerpDiag	Initial Pass/Fail: Fail	Overall Compliance: No	Severity Score: 25

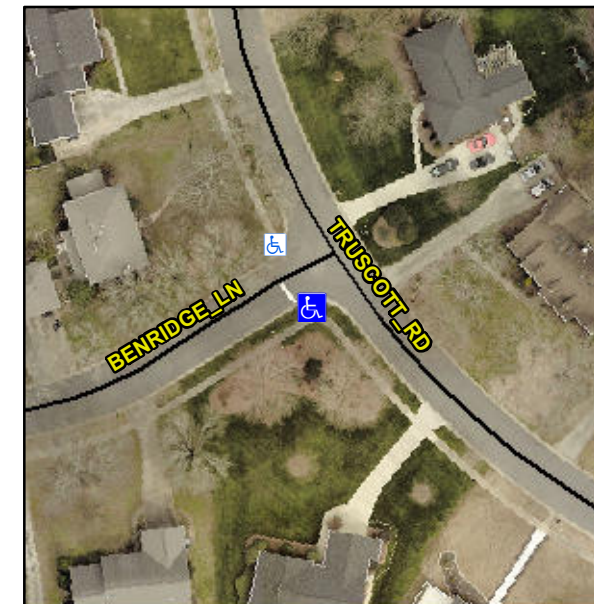
Not Found, R304.5.3

Compliance	Description	Data	Compliance	Description	Data
N/A	Ramp Length (in)	80.5	Yes	Ramp Slope (%)	7.4
Yes	Ramp Width (in)	69.0	No	Ramp XSlope (%)	7.3
N/A	Flare Type LT	N/A	N/A	Flare Type RT	N/A
N/A	Flare Slope LT (%)	N/A	N/A	Flare Slope RT (%)	N/A
N/A	Flare Traversable LT?	N/A	N/A	Flare Traversable RT?	N/A
N/A	Landing Length (in)	N/A	N/A	DWS Provided?	N/A
N/A	Landing Width (in)	N/A	N/A	DWS Contrast?	N/A
N/A	Landing Slope (%)	N/A	N/A	DWS Length (in)	N/A
N/A	Landing X Slope (%)	N/A	N/A	DWS Full Width?	N/A
N/A	Landing Curb? (Y/N)	N/A	N/A	DWS Offset (in)	N/A
N/A	Shared Landing?	N/A			
N/A	Gutter Ponding?	N/A	N/A	Gutter Slope (%)	N/A
N/A	Gutter Lip Ht (in)	N/A	N/A	Gutter X Slope (%)	N/A
N/A	Painted X Walk1?	No	N/A	Painted X Walk2?	No
	X Walk 1 Direction	To E		X Walk 2 Direction	To N
N/A	X Walk 1 Width (in)	N/A	N/A	X Walk 2 Width (in)	N/A
	X Walk 1 Slope (%)	3.8		X Walk 2 Slope (%)	0.1
	X Walk 1 X Slope (%)	1.2		X Walk 2 X Slope (%)	4.0

Remove & Replace Curb Ramp With Two New Directional Ramps or Equivalent.
